# Ft. Pearce Wash

## River Mining Plan

Washington County, Utah

March 2007

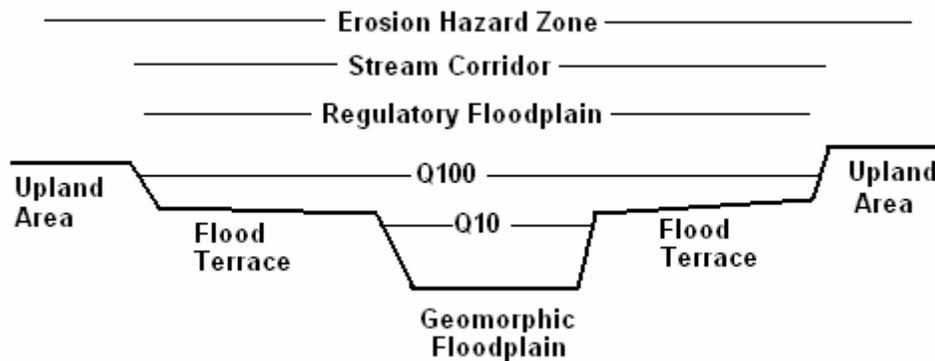
The basic recommended channel cross section mimics the natural channel features observed and measured by NCD along undisturbed portions of Fort Pearce Wash, and incorporates the City’s flood control objectives within the desired right-of-way width. The basic stream corridor cross section consists of the following elements shown in Figure 1:

- **Geomorphic Floodplain.** The geomorphic floodplain contains the low flow (main) channel and a frequently inundated floodplain. No development occurs within the geomorphic floodplain, which is intended solely for flood conveyance and open space. Trails may be located within the geomorphic floodplain, but they will be subject to damage during small to moderate flow events and during periodic channel maintenance activities. The geomorphic floodplain should contain the 10-year flood without inundating the terraces, and also contains the USACE jurisdictional area (waters of the United States).

- **Upland Areas.** Upland areas are the lands located outside the flood terrace which are elevated above the 100-year flood elevations. Upland areas are outside the regulatory floodplain, but may be located within an erosion hazard zone (EHZ) depending on local conditions. The upland areas are potentially developable if located outside the erosion hazard zone or if erosion protection is provided.

*Figure 1. Schematic Drawing of the Recommended Channel Corridor Template Elements. (NTS)*

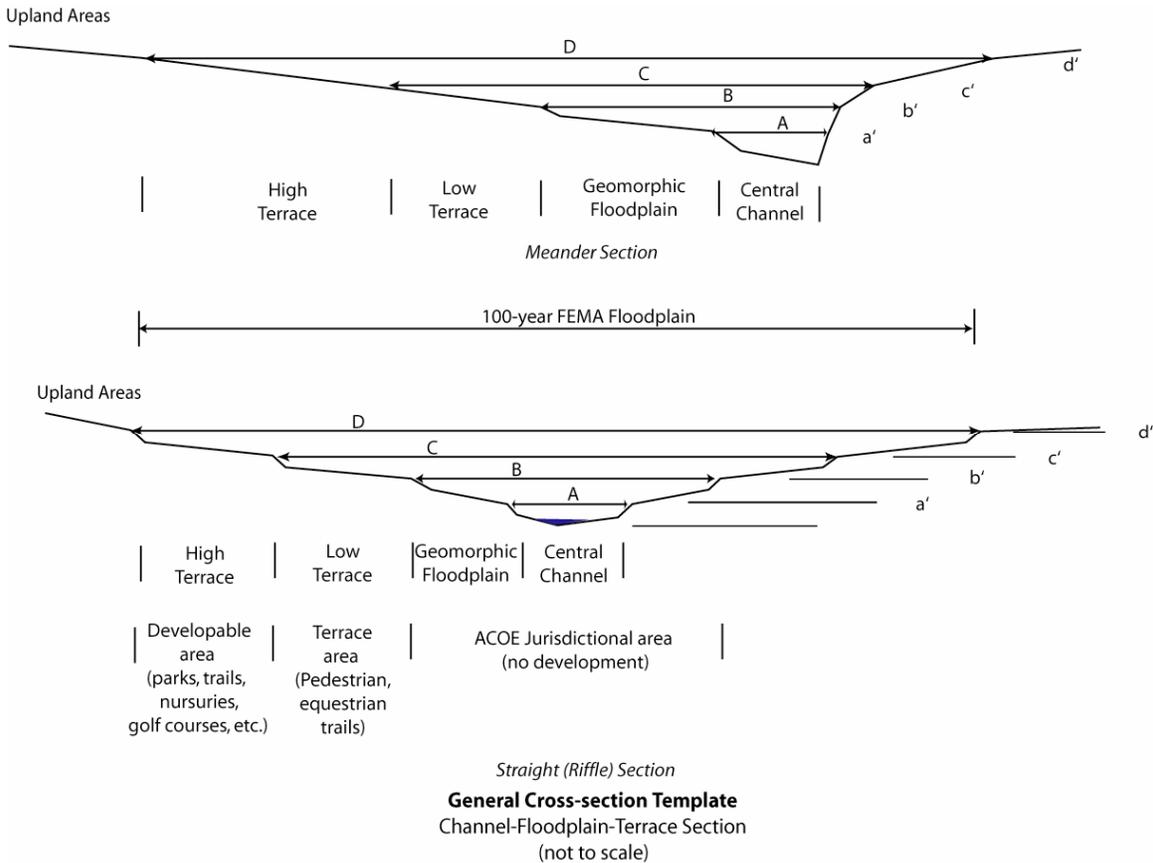
The constructed channel cross sections geometry is described in Table 2 and shown in Figure 2. Hydraulic data for a 300-foot and 350-foot wide corridor are provided in Tables 3 and 4, respectively. Allowable or desired vegetative cover is listed in Table 5. The template cross section geometry should be considered as draft only, since more detailed analyses are recommended prior to construction. Some of the issues to be considered in final design include increasing the geomorphic floodplain capacity, lowering terrace velocities, corridor freeboard, and erosion protection.

Figure 2. Ft. Pearce Wash Channel Template for the 300-foot Cross Section

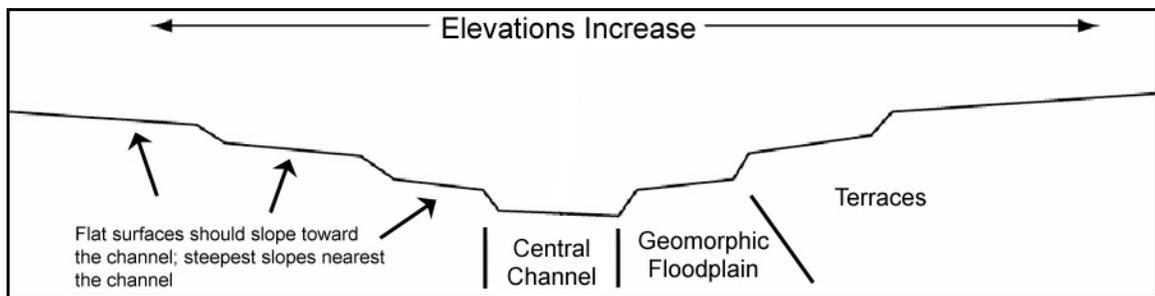
- **Elevations should rise away from the central channel.** The central channel flowline must be the lowest point across the riparian area and the channel banks, floodplains, and terraces should slope upward continuously away from the channel. The outer banks of the stream corridor will be most stable if the terraces can be stepped as they rise away from the channel (Figure 3). All existing flat areas should slope toward the river. If they are level or slope away from the river they will tend to divert overbank flows away from the main channel and could contribute to greater erosion. Surfaces on the outside of meanders should rise in elevation more rapidly than those on the inside but should still be stepped when possible.

*Figure 3. Appropriate channel/floodplain elevations*

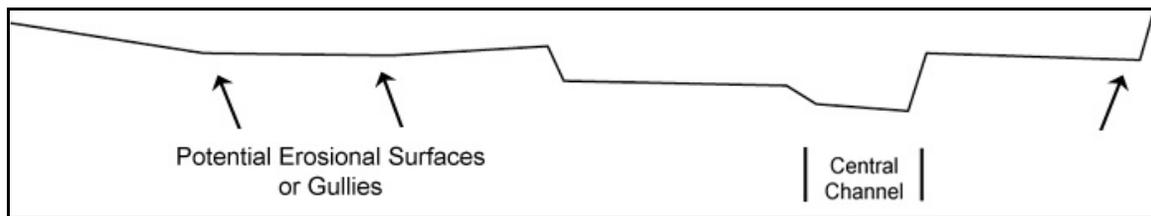
Diagrams of some common problematic river/floodplain cross sections are shown in Figure 4.

*In this example, overbank areas are not sloped toward the central channel. Flow that overtops these banks may be trapped away from the channel and create erosion along the surfaces or gullies as the flow reenters the channel downstream*

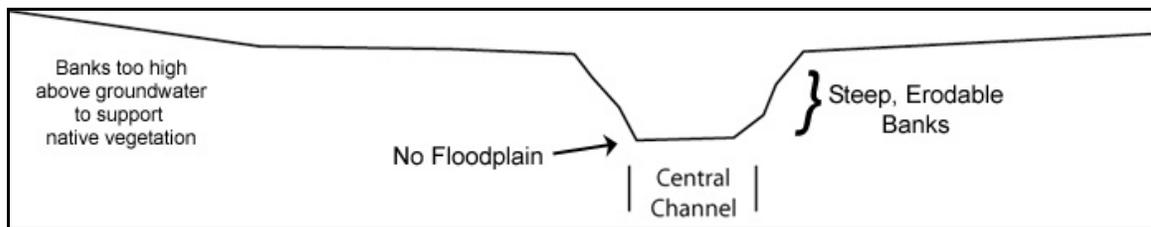
*In this example, lack of a set of stepped floodplain/terrace features contains the flows but increases the velocities and erosion potential within the central channel. Once the banks begin to give way, the erosion can be extreme and unpredictable. Eventually flow will overtop the high banks and create erosion across the surface as well. High banks are often well above permanent ground water and cannot sustain robust plant communities.*

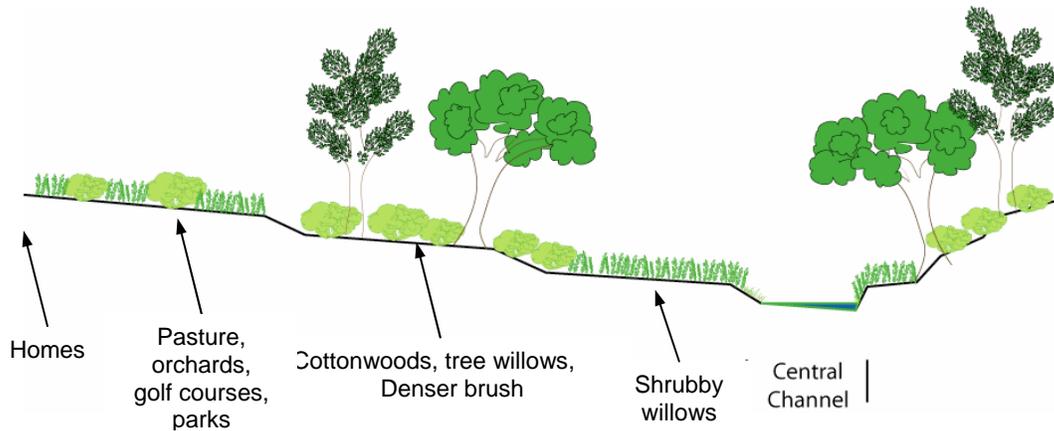
- Roughness should increase away from the central channel.** Roughness is resistance to flow contributed by vegetation, uneven surfaces or structures that block flow. Increasing roughness away from the central channel tends to center high flows and slows velocities against the outer banks and terraces. For example, the central channel should be relatively free of vegetation and other obstructions. The areas immediately adjacent to the channel (floodplains) should support dense thickets of shrubby vegetation (i.e., willows, etc) that bend with the flows (Figure 5). Areas further away from the channel (terraces) support stiffer woody vegetation (cottonwoods, Black willow, etc) that further slows flows. It should be noted that roughness implies a slowing of the flow not necessarily stopping the flow. Structures that completely stop or redirect flow across the floodplain/terrace should be avoided.

*Figure 5. Appropriate Roughness Distribution. Vegetation provides increasing roughness to keep high velocities in the central channel.*

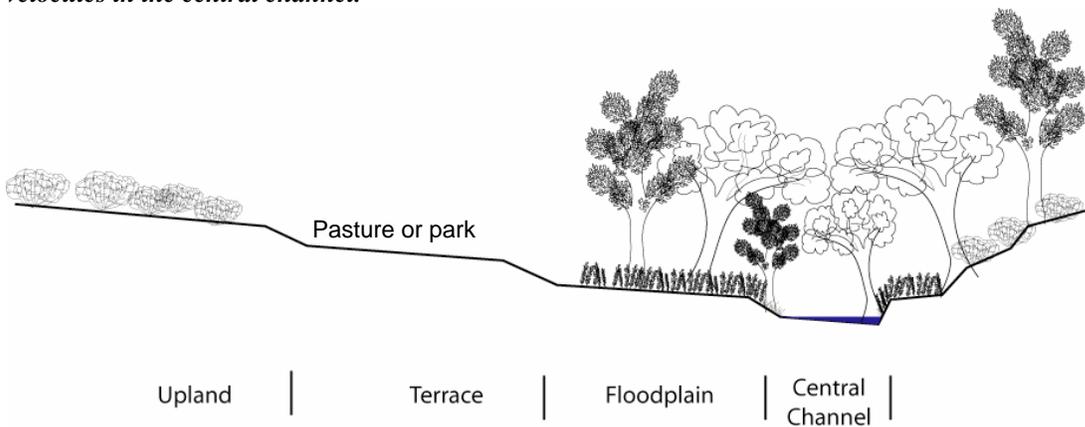
*Figure 6. Incorrect Roughness Distribution. Dense stiff species choke channel the stream channel forcing flows to the vulnerable outer banks. Smooth surface of pasture creates high velocities and erosion.*

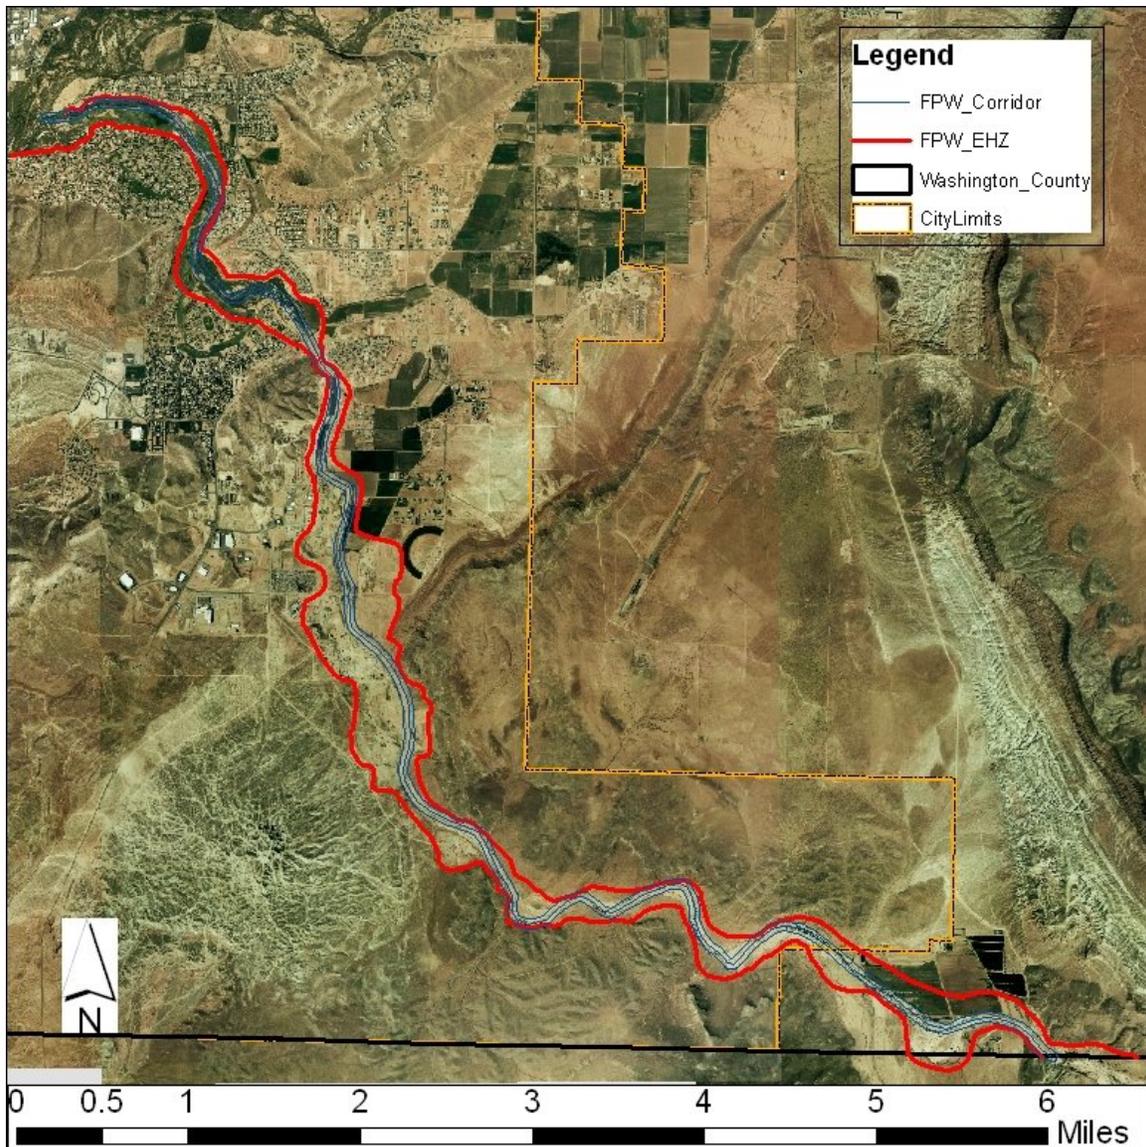
A preliminary channel alignment for a 300-foot corridor is shown in Figure 8.<sup>5</sup> The preliminary alignment generally follows the existing “natural” thalweg, except where individual landowners indicated that they may realign portions of the stream as part of a development plan (e.g., Desert Canyon Development). Wherever possible, the preliminary alignment is located within the regulatory floodway and the zone of active sediment transport, as delineated for the Fort Pearce Wash erosion hazard delineation. An attempt was also made to align the preliminary corridor to take advantage of existing bank stabilization, bedrock outcrops, and stable surfaces. Also, where information on existing utilities was available, the alignment attempts to avoid utility conflicts.

Figure 8. Preliminary channelization corridor alignment along Fort Pearce Wash.

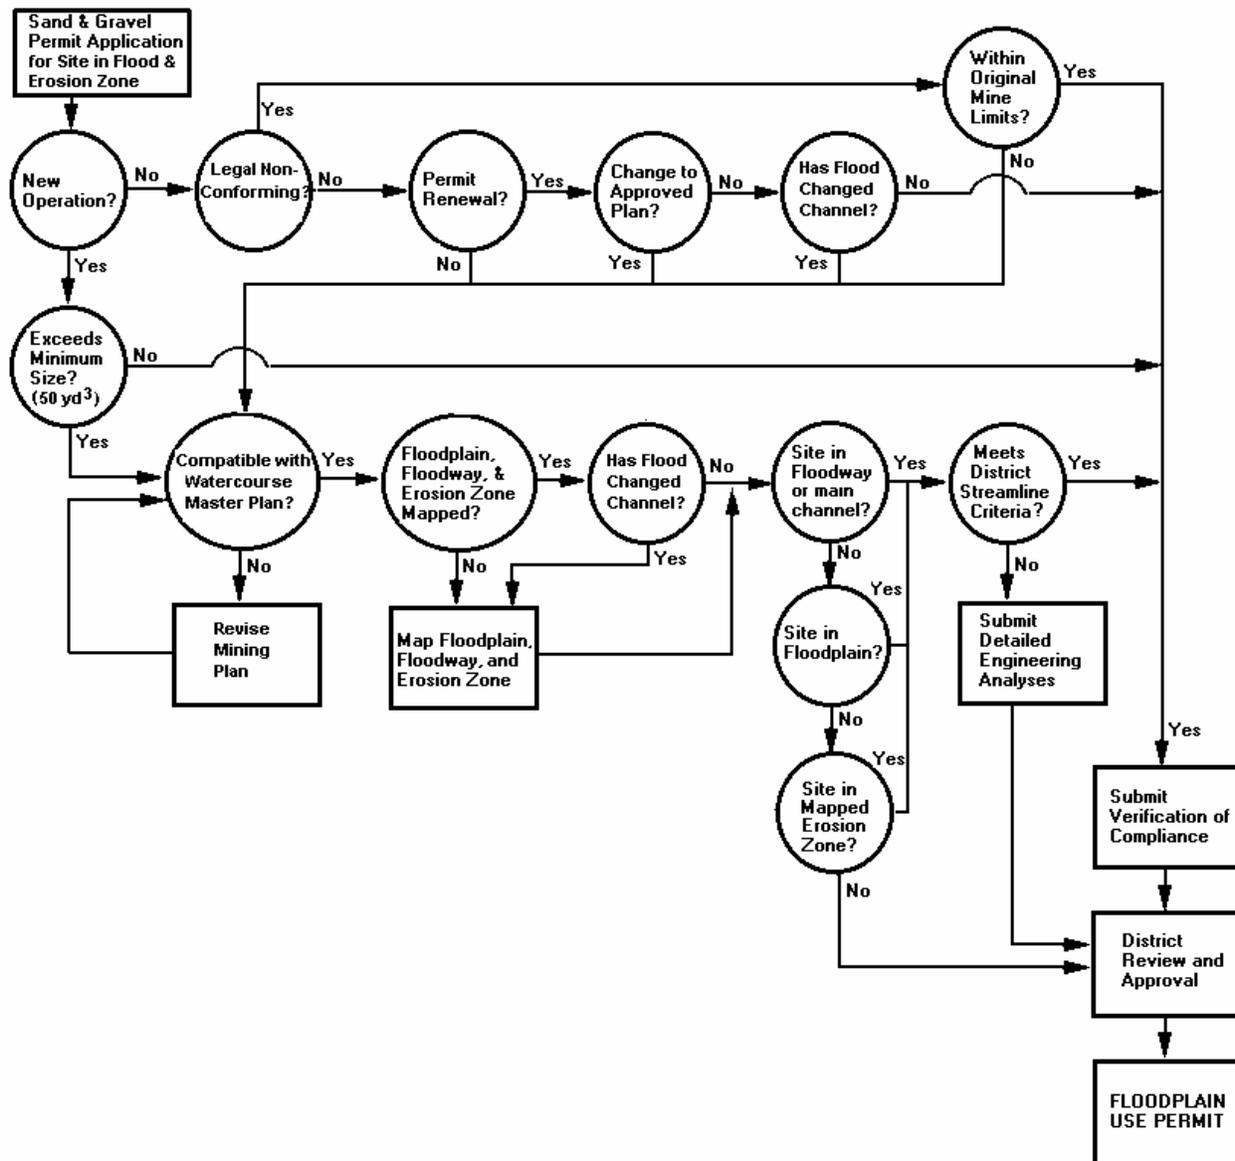
Figure 1-1. Flow chart showing the floodplain use permit application process for sand and gravel mines.

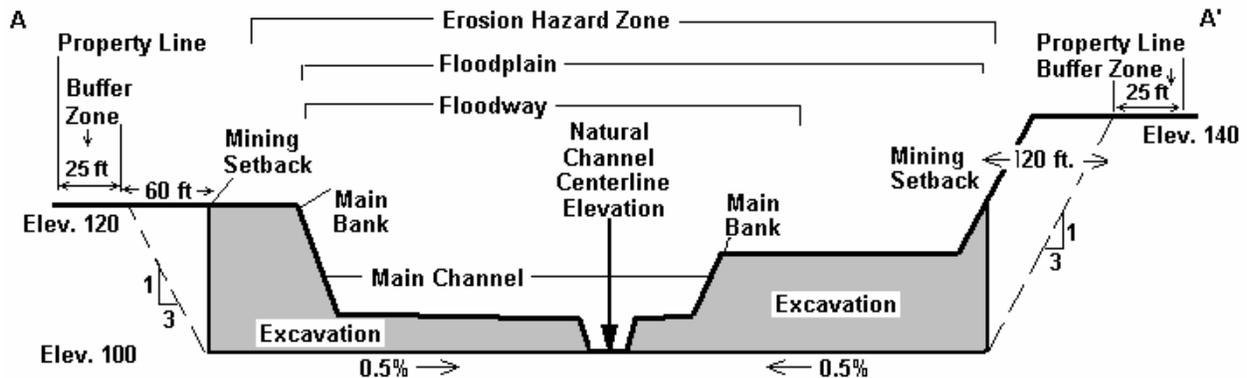
Figure 5-1. Main channel and floodway excavation geometry for streamlined floodplain use permits. Plan view is shown in Figure 5-2. This pit is 20 feet deep (Elev. 120 – Elev. 100). The shaded area marked “Excavation” is the area that can be mined under the streamlined permit process. Material may not be excavated from areas outside the shaded zone unless an engineering analysis is submitted.

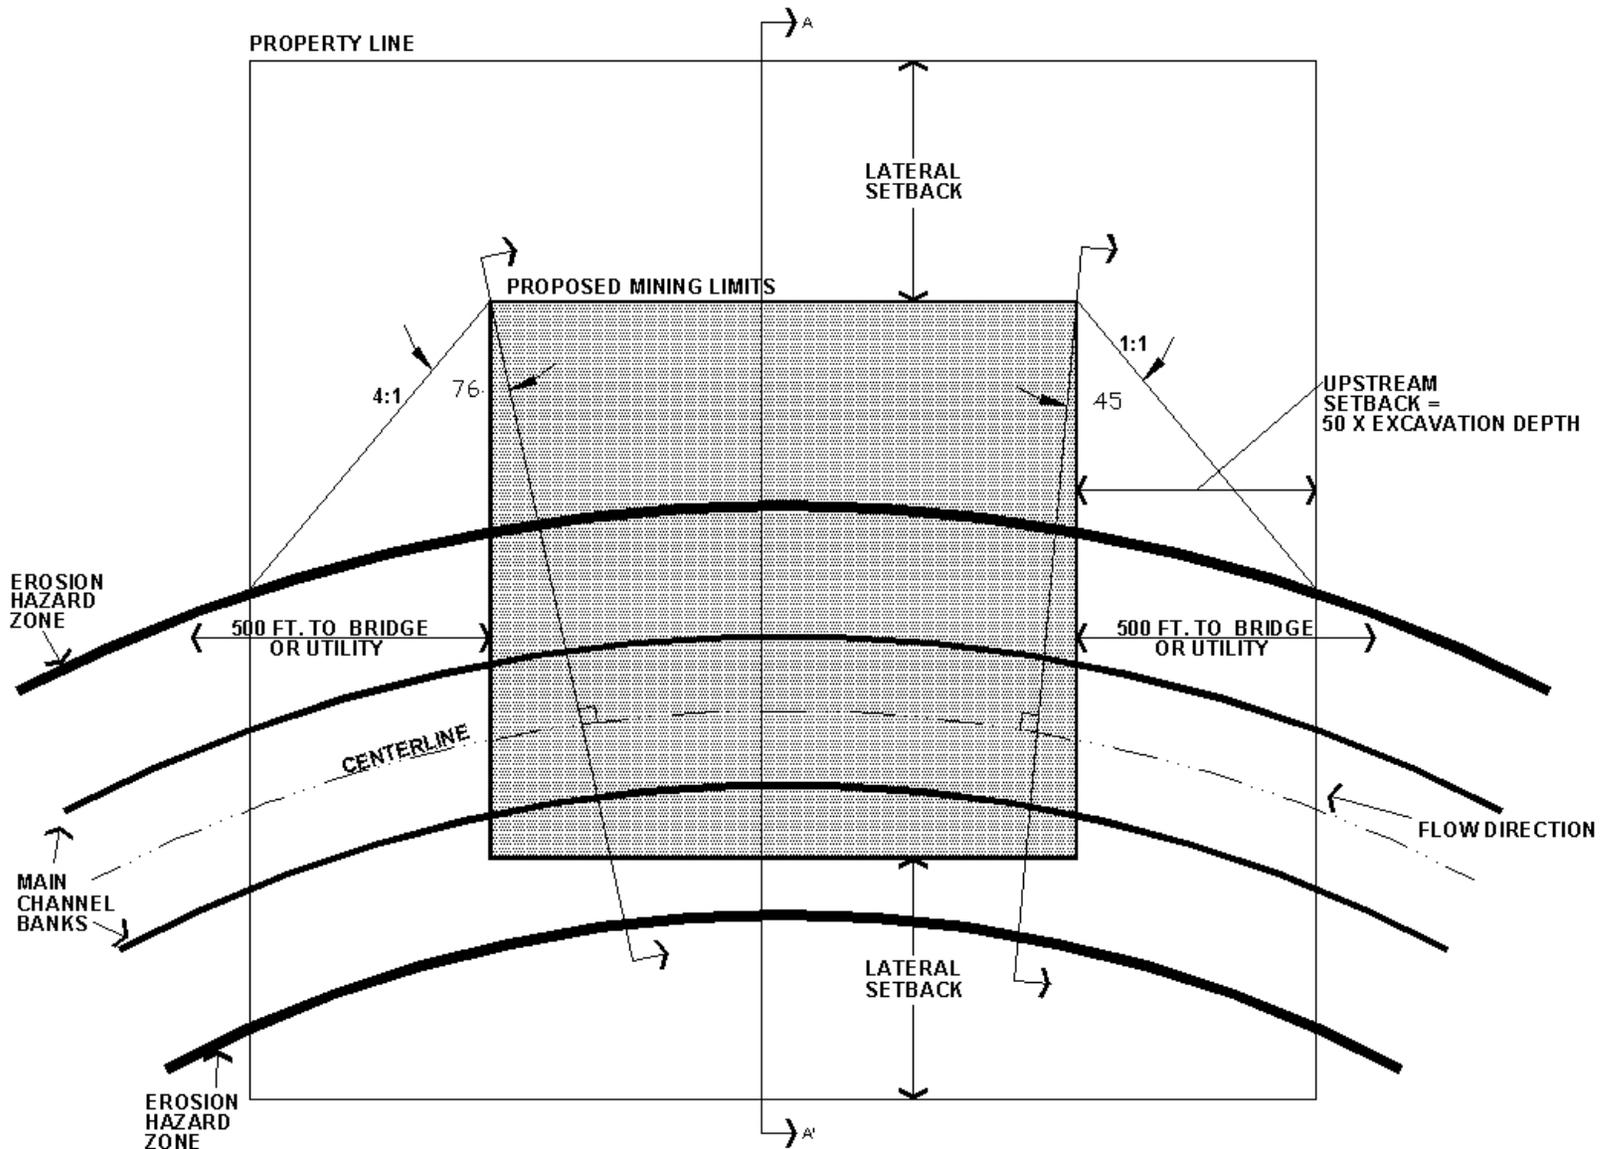
Figure 5-2. Upstream and downstream setbacks from property lines for excavations that extend outside the erosion hazard zone.

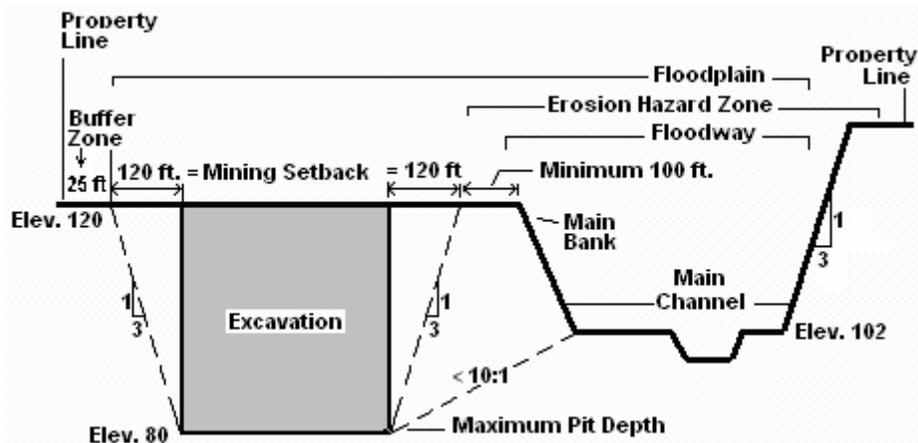
Figure 5-3. Floodplain excavation pit geometry for streamlined floodplain use permit. Pit is 40 ft deep.

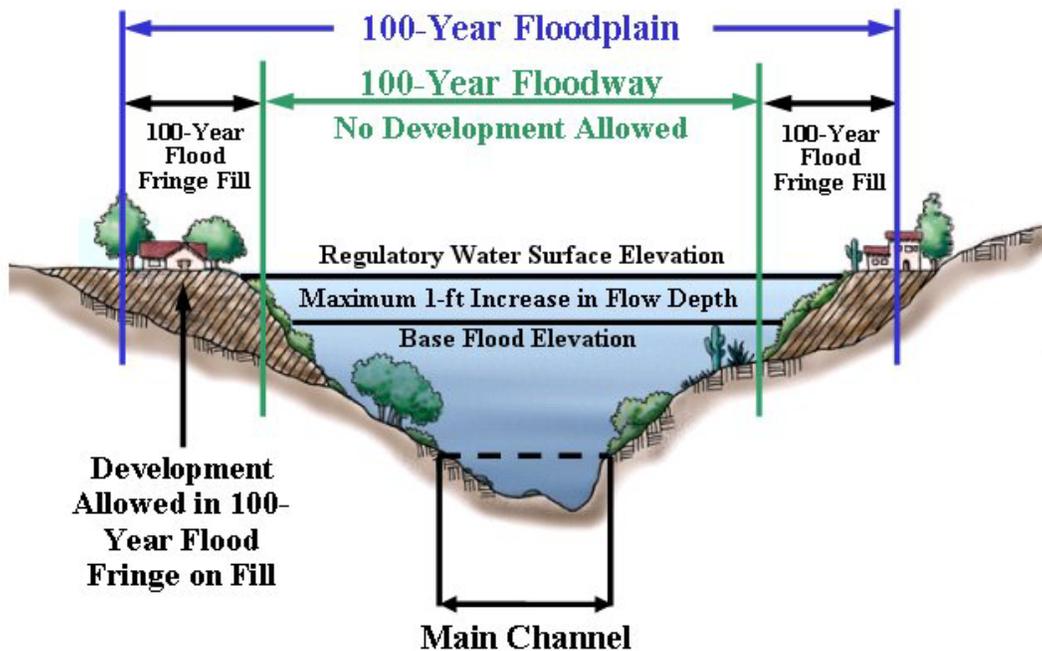
Figure 6-1. Illustration of Floodway, Floodway Fringe, Base Flood Elevation, and Regulatory Water Surface Elevation for a typical riverine floodplain.

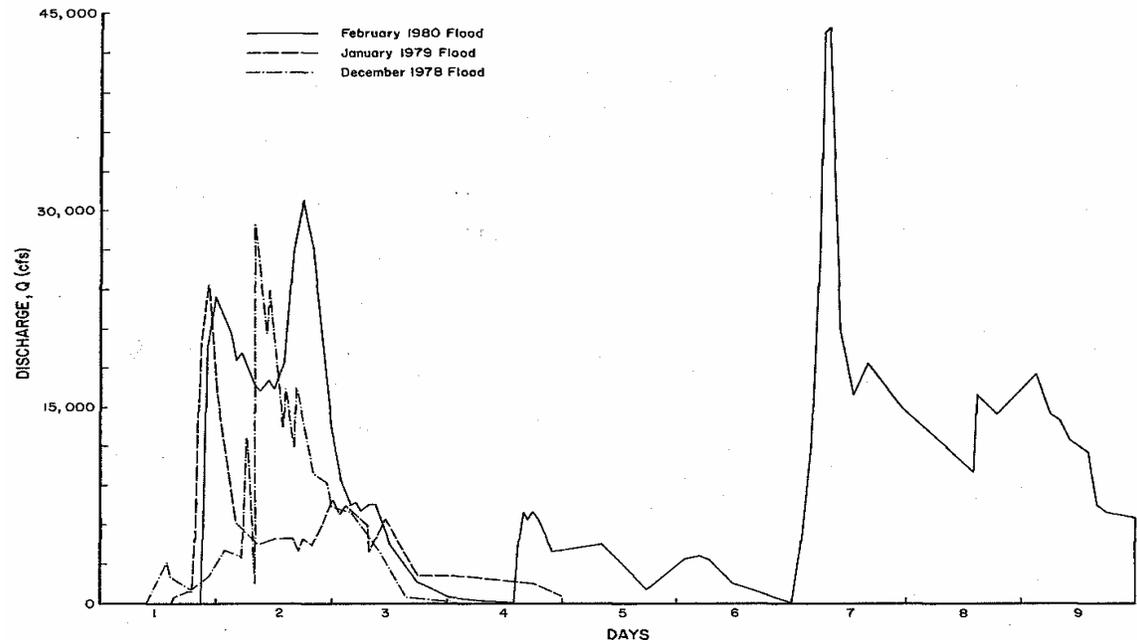
Figure 5. Estimated flood hydrographs for the 1978, 1979, and 1980 floods on the Agua Fria River at the Avondale gauge (Source: USACE, 1981). Note the rapid rise of the hydrograph on Feb. 20<sup>th</sup> 1980 where discharge jumped from 18,000 to 44,000 and back to 18,000 in less than 8 hours.

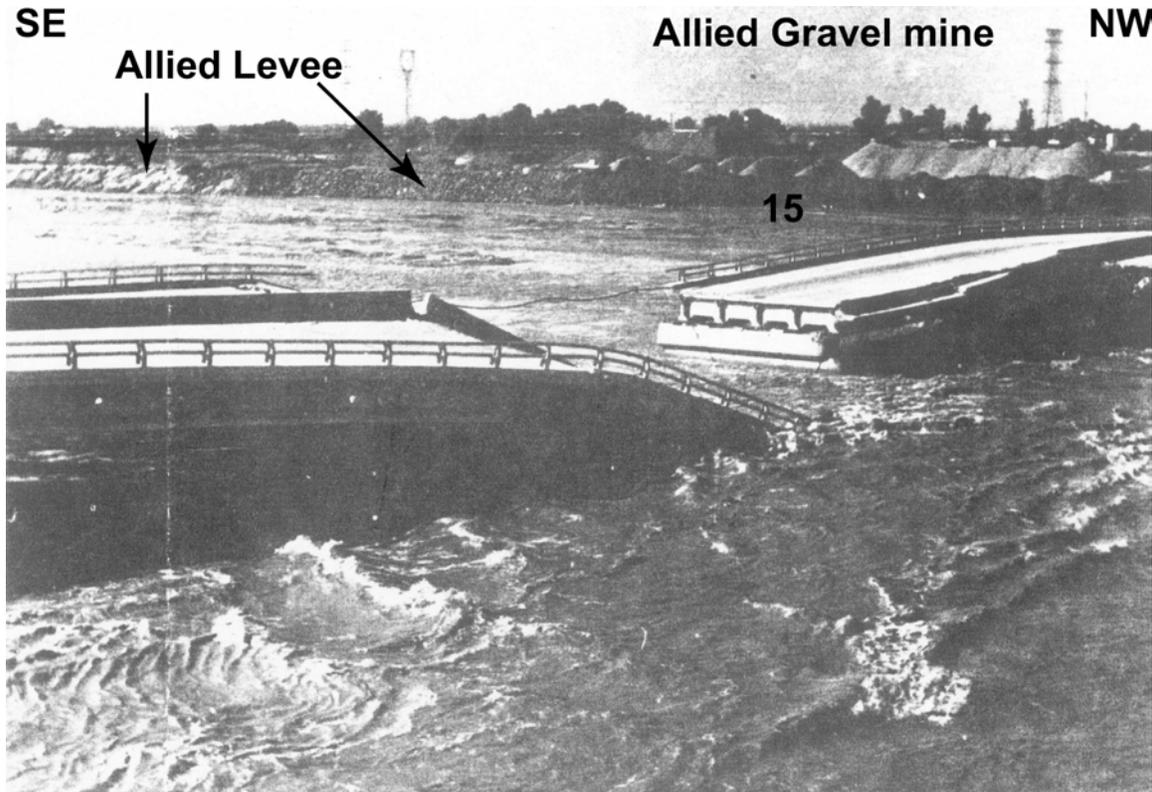
At 8:15 a.m. on February 20, Maricopa County highway workers noticed a sag in the Indian School Road Bridge. Within 10 minutes, a section near the eastern end of the bridge had dropped by 2.5 feet. About an hour later the bridge span between piers 15 and 16 collapsed into the river, leaving only two intact crossings over the Agua Fria River and tying up traffic for weeks (Arizona Republic, 1980). Photographs of the collapsed bridge are shown in Figures 6 to 8.

*Figure 6. Photograph looking downstream at the Indian School Bridge collapse during the 1980 flood.*

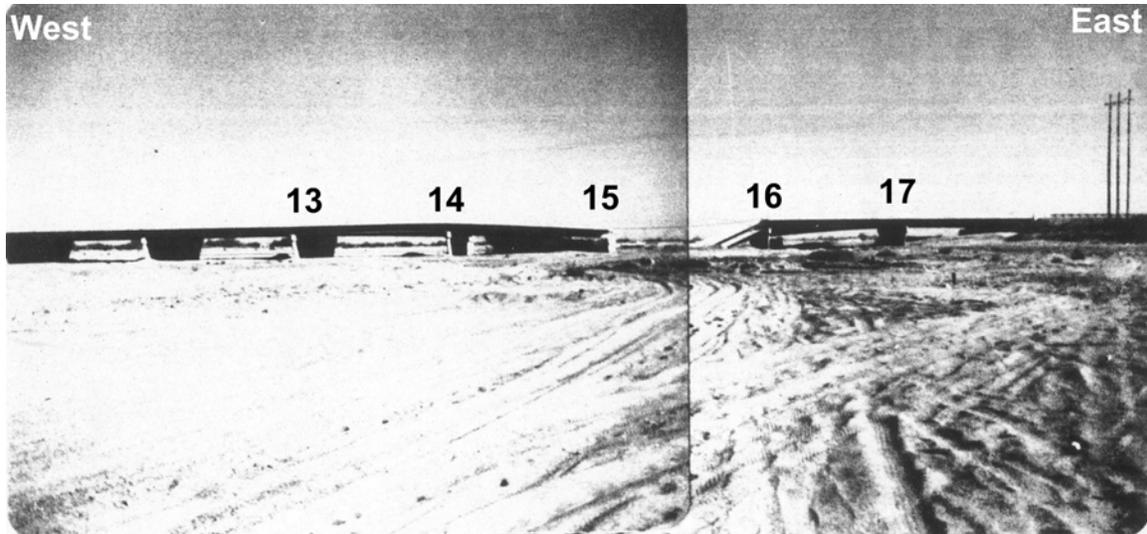
Figure 7. Photograph looking upstream at failed bridge after February 26<sup>th</sup>. Pier numbering indicated.

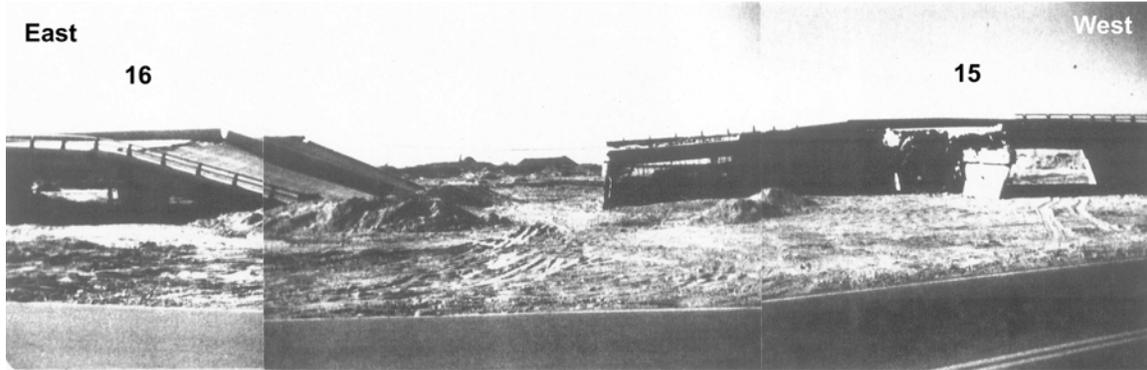
Figure 8. Photograph looking downstream (south) at failed bridge after February 26<sup>th</sup>.

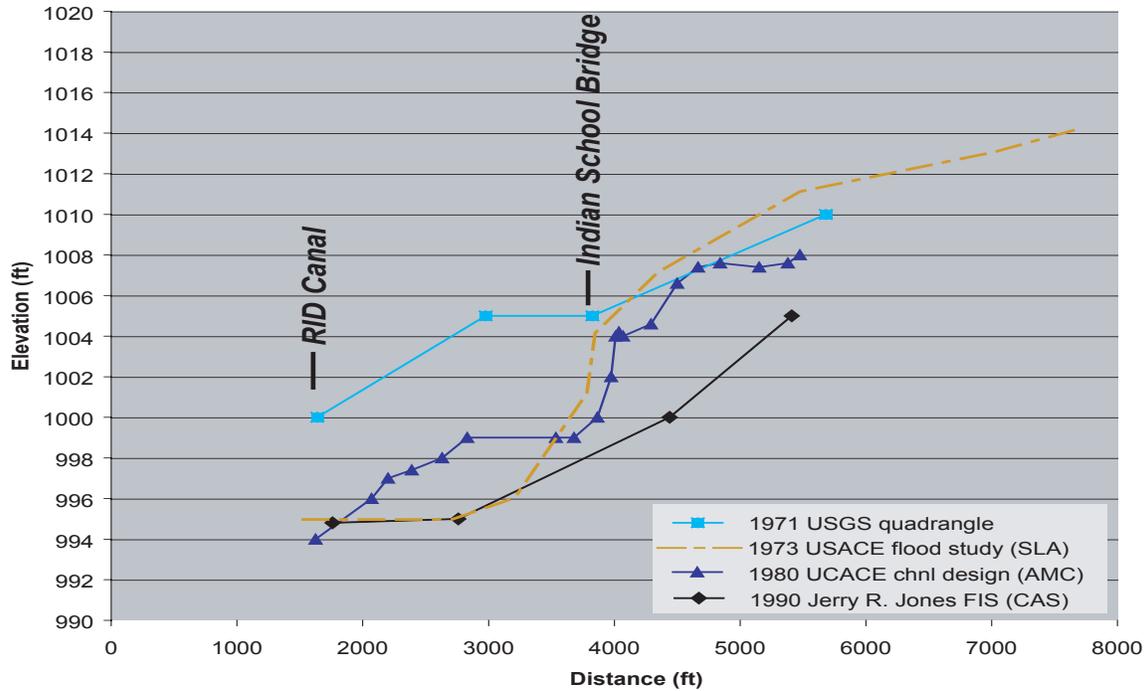
Figure 9. Thalweg profiles for the Agua Fria channel bed.

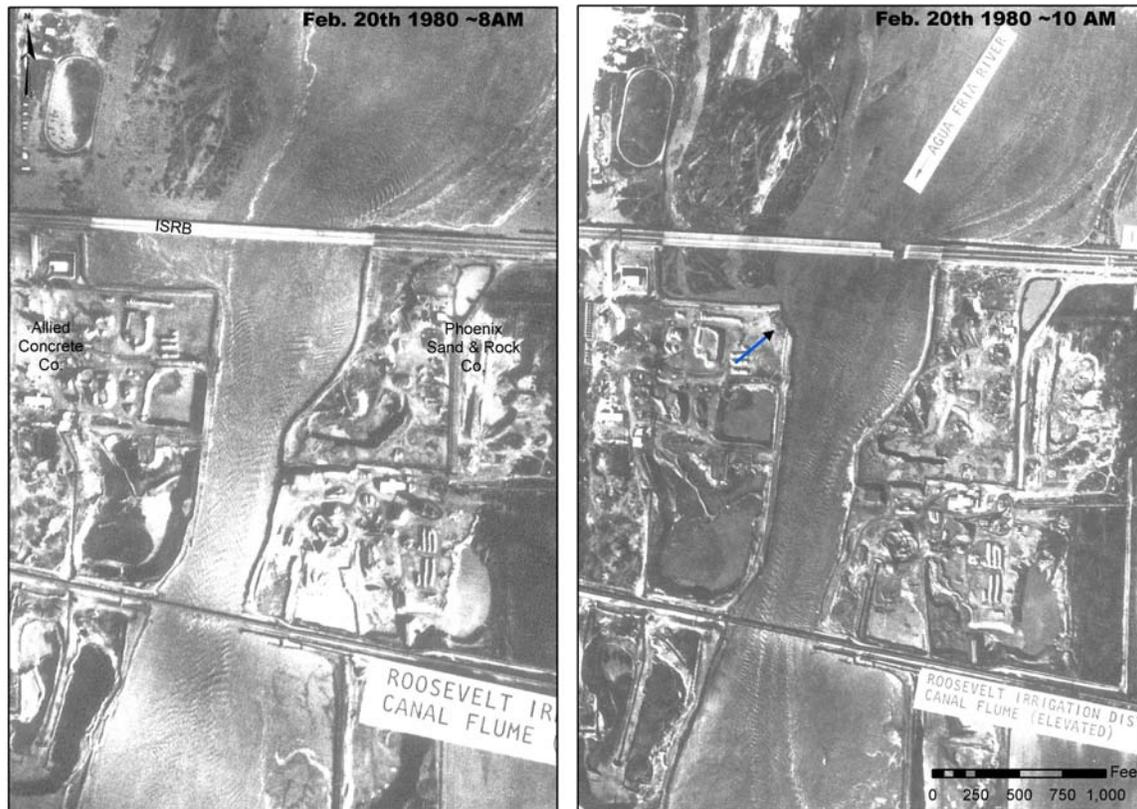
**Figure 10.** February 20<sup>th</sup>, 1980 aerial photographs taken before and after the Indian School Road Bridge collapse. Note the flow constriction at the ISRB, high angle of flow to the eastern piers, and erosion of the tip of the western levee (blue arrow).

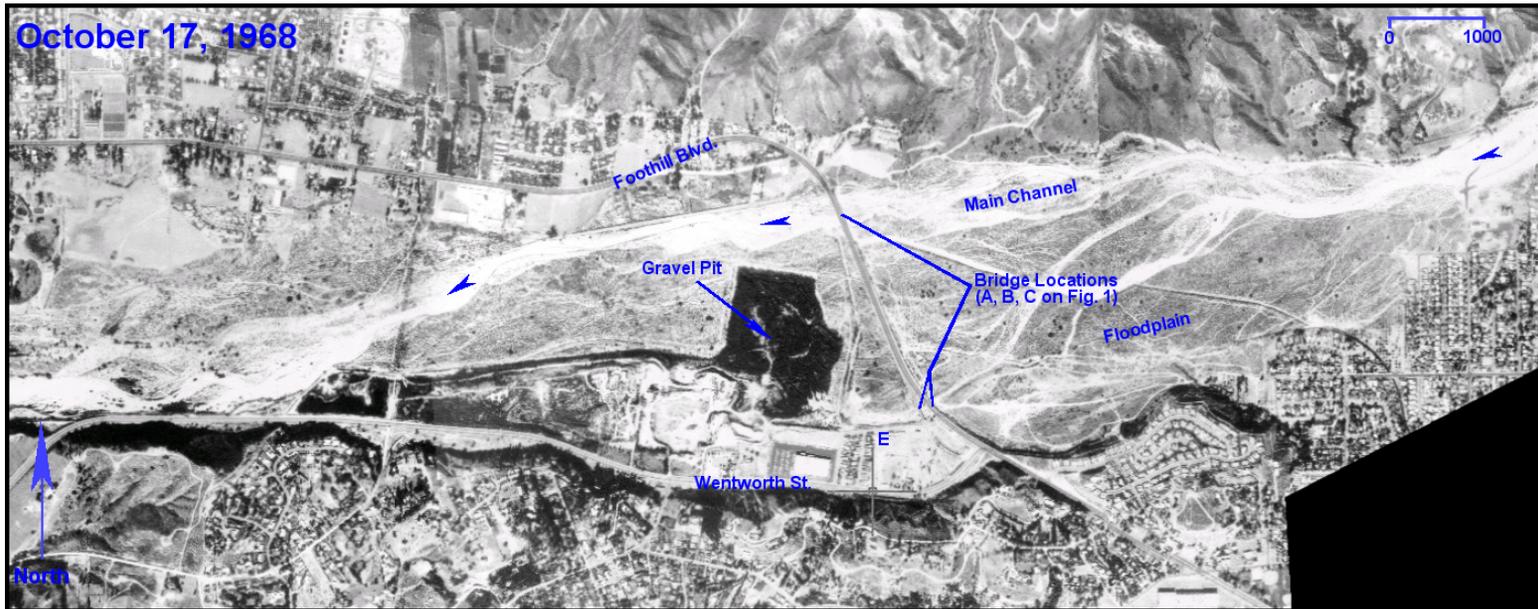
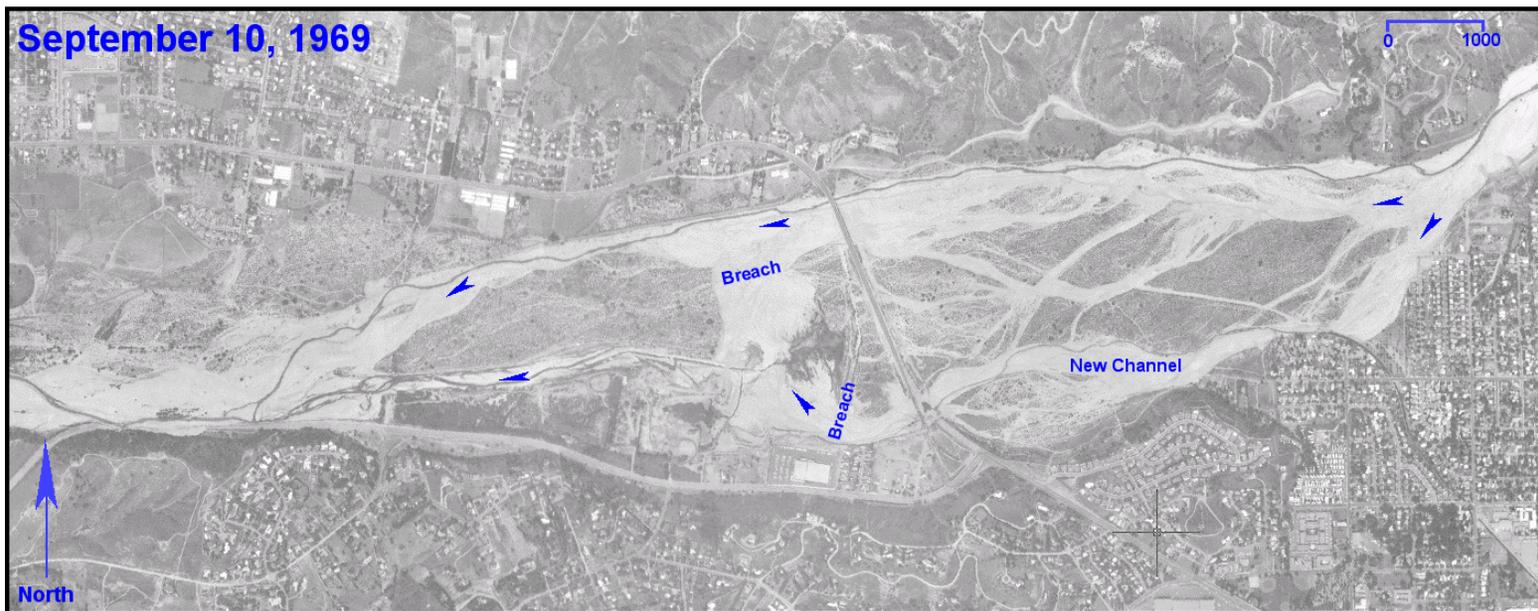
Figure 4. Pre- and post-flood view of entire reach. Note: 1969 photography was taken after two of the original three bridges were replaced.

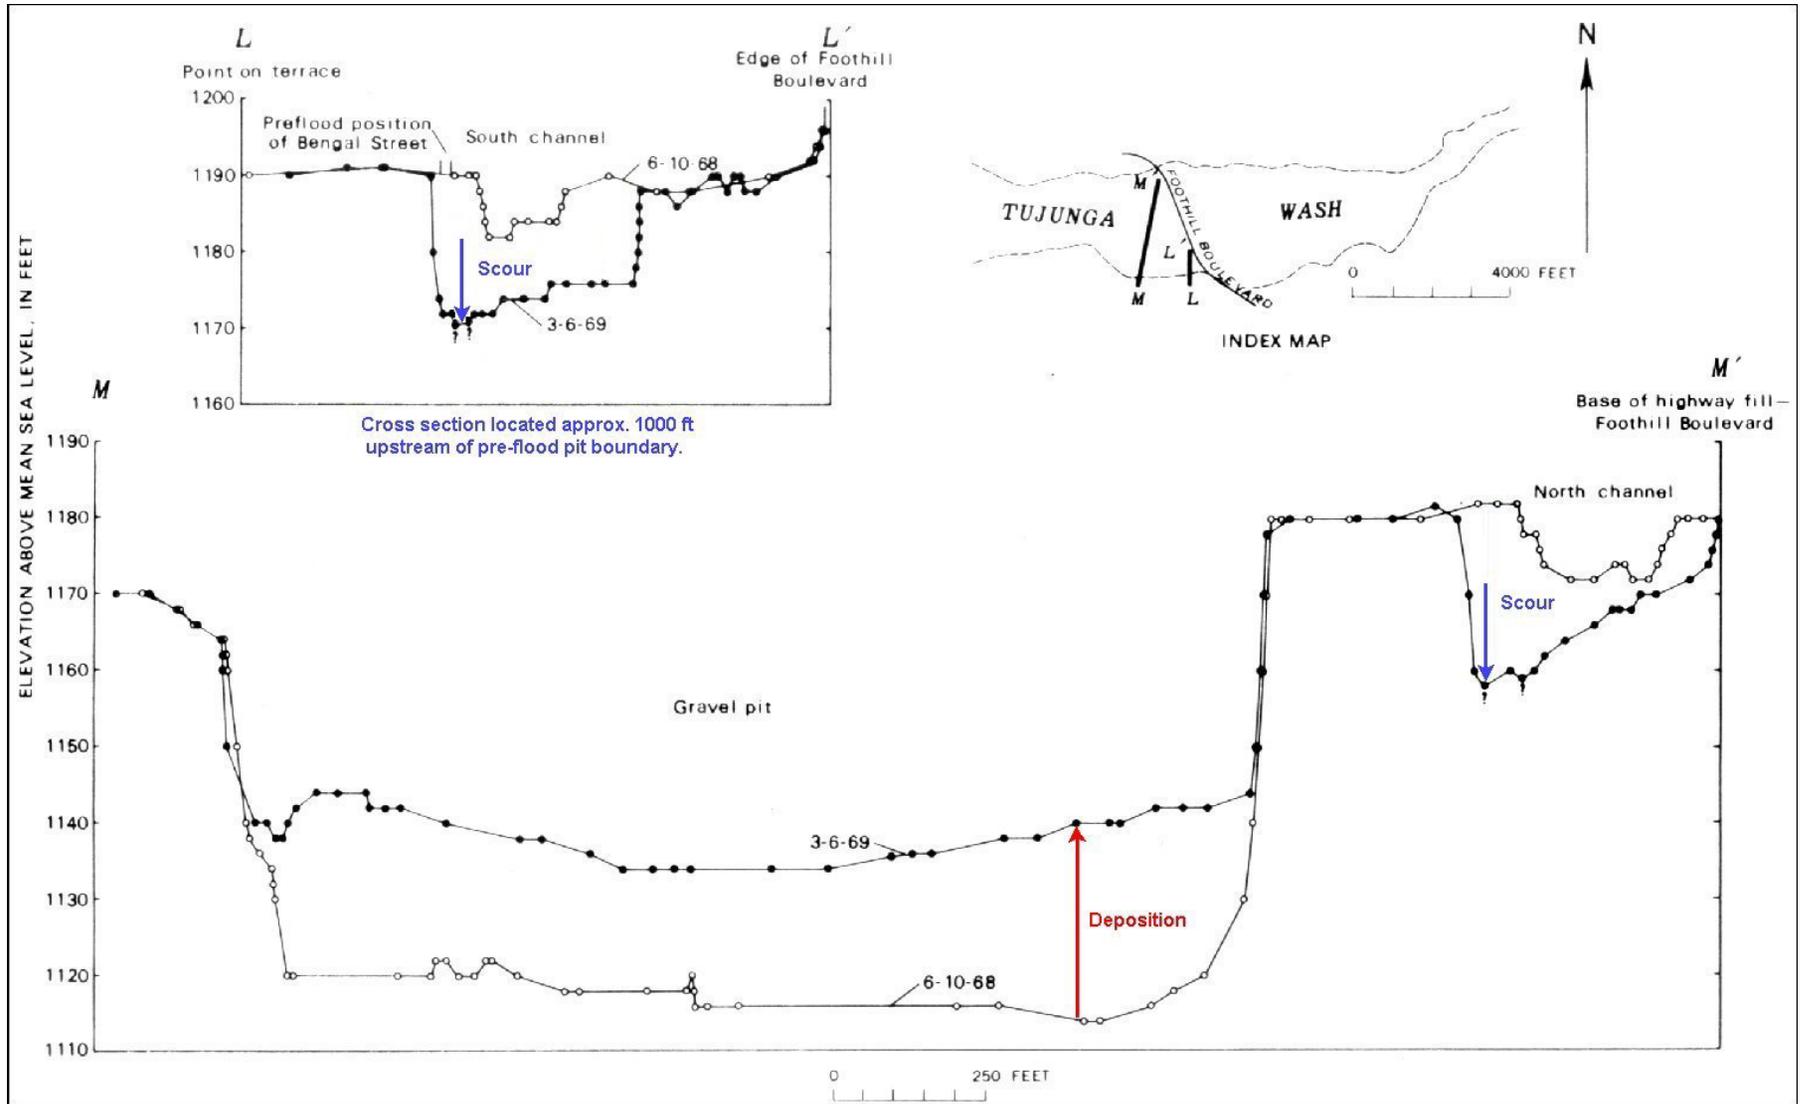
Figure 5. Figure showing example of bed elevation change at two locations on Tujunga Creek. Cross section M-M' is across gravel pit and cross section L-L' is located just upstream of the gravel pit (Original figure taken from Scott, 1973).

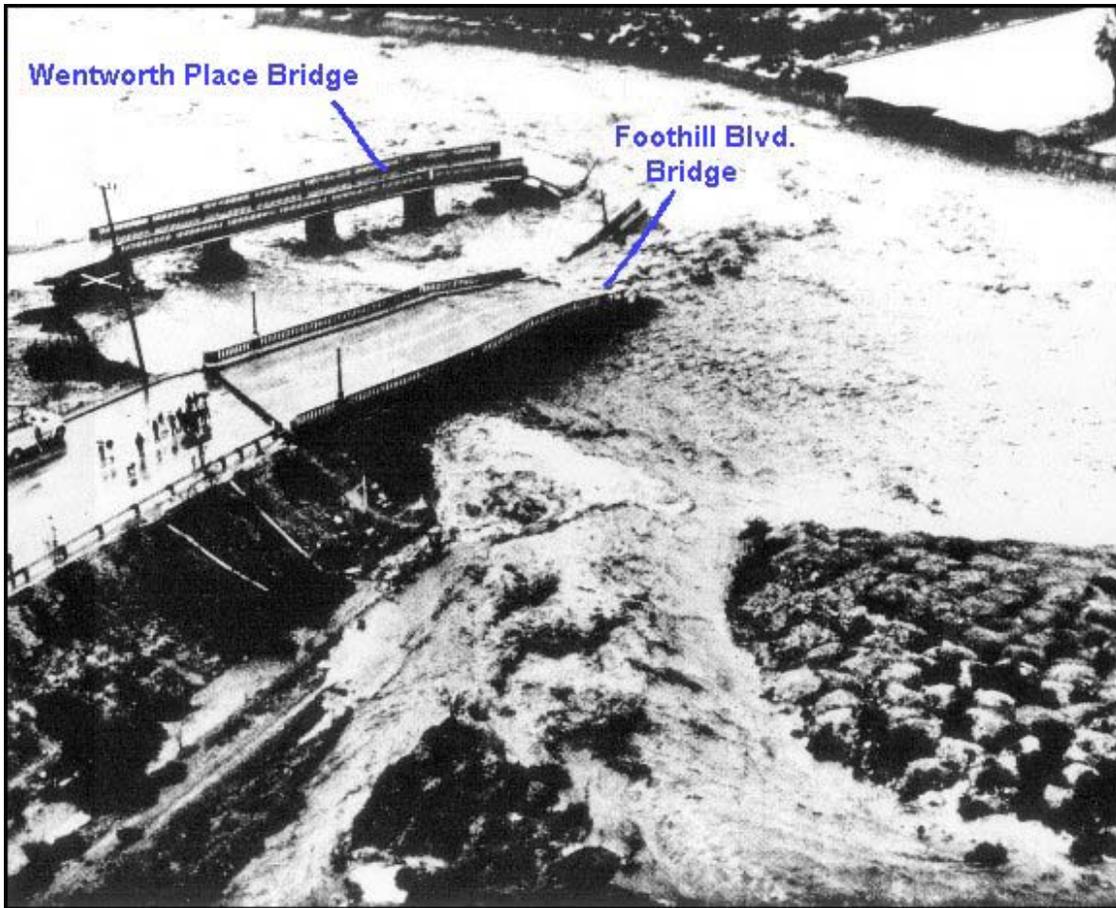
*Figure 6. Picture by Harold Morby looking downstream (NW) at Foothill Blvd. and Wentworth Place bridge failures (from Scott, 1973).*

right was also eroded downstream of the southern channel bridge crossings in the same location (Figure 6). Scott (1973) stated that lateral erosion in excess of the natural rate of lateral erosion occurred near the sand and gravel pit due to two major factors. First, the channel widened to compensate for the significant increase in discharge capacity caused both by the large flood itself and by erosion and degradation that increased the percentage of flow conveyed in the channel instead of the floodplain. Second, bank stability decreased due to headcutting initiated by breaching of the gravel pit. Lowering of the bed elevation by headcutting increased the bank height, removed basal support at the bank toe, exposed unvegetated bank material to hydraulic forces, and increased the channel velocity. Pre- and post-flood aerial photography shown in Figures 4 and 8 can be compared to indicate the magnitude and extent of lateral channel changes.

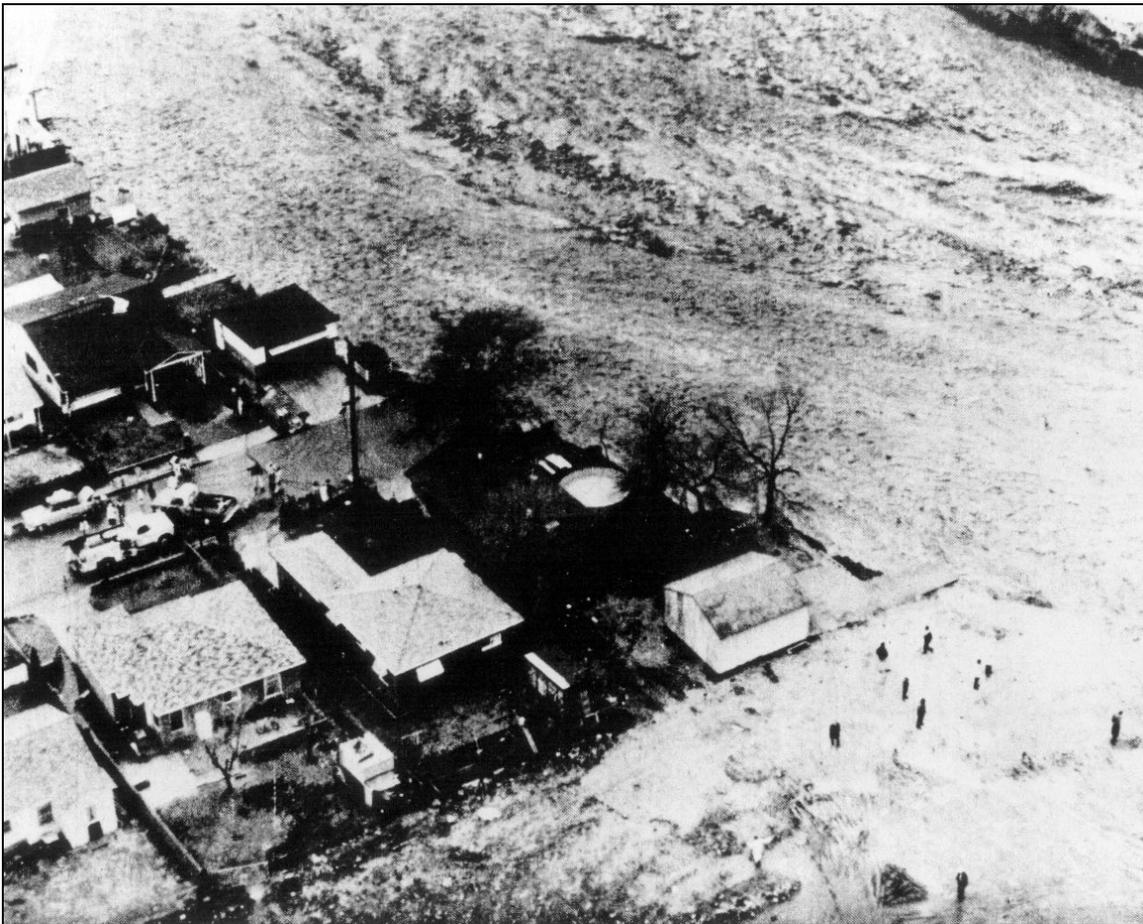
*Figure 7. Photograph by Harold Morby looking downstream (NW) at lateral erosion of left bank near Bengal Street. From Scott, 1973. See Figure 8 for photo location.*
