# Ft. Pearce Wash

## River Mining Plan

Washington County, Utah

March 2007

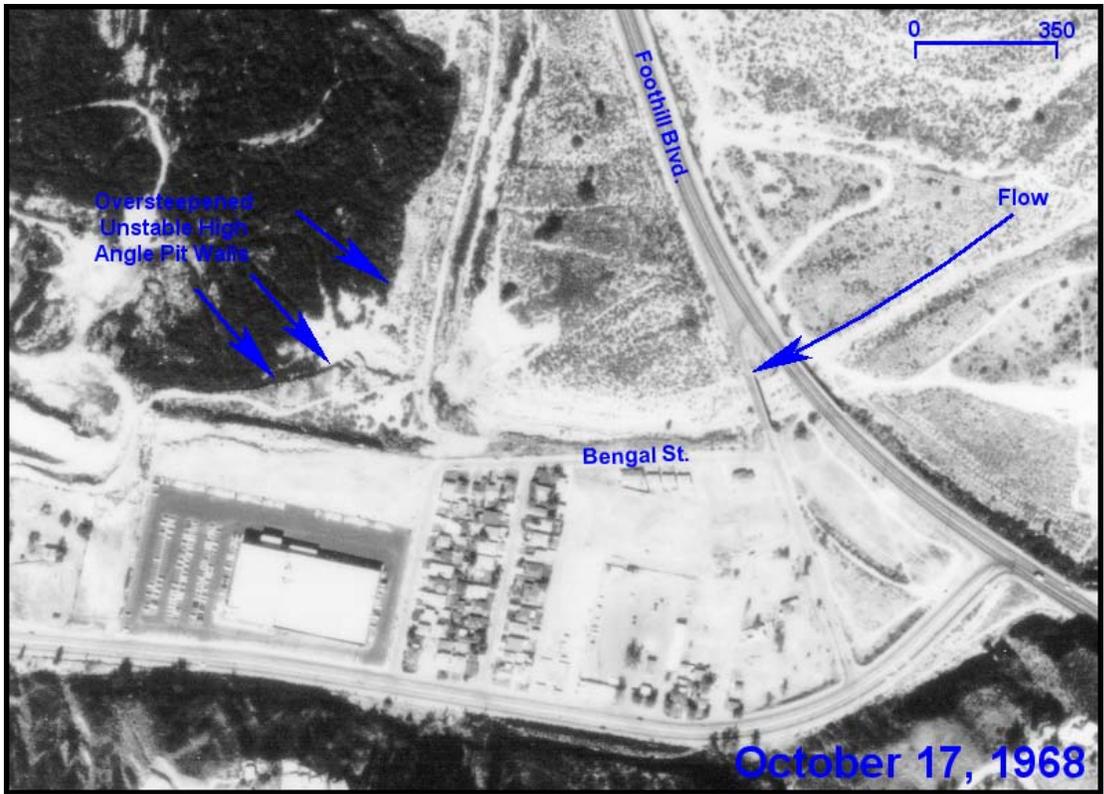
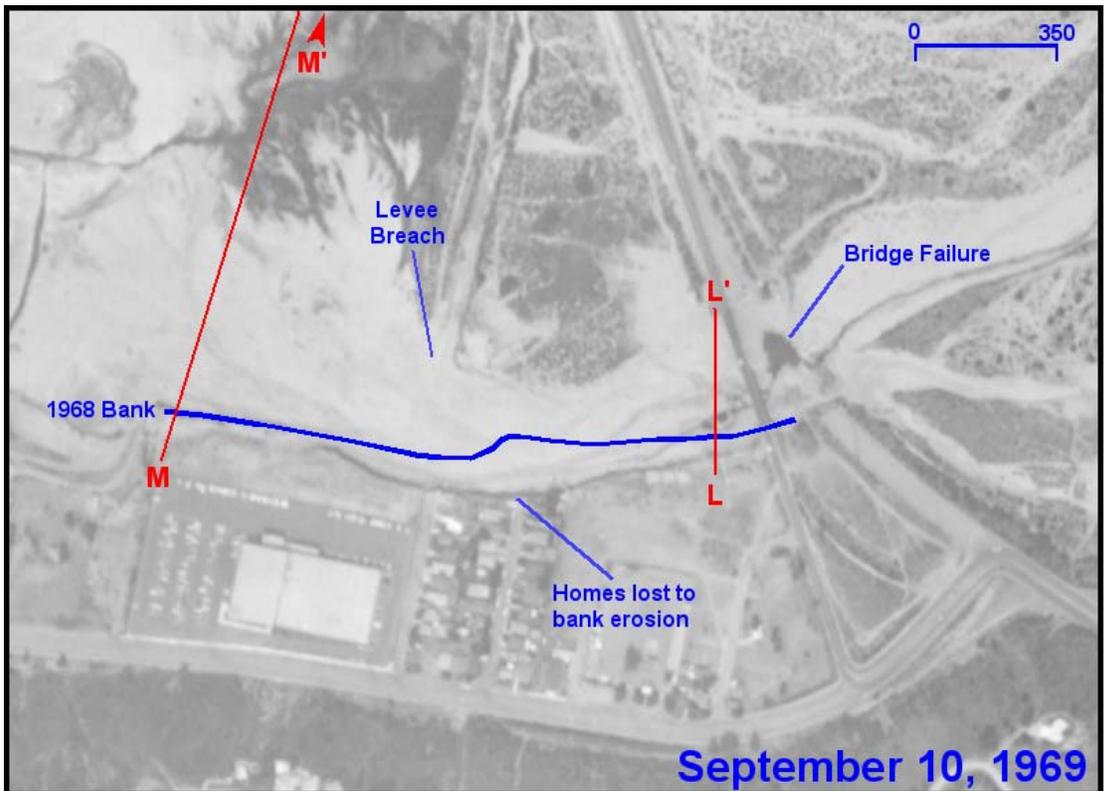
Figure 8. Lateral bank erosion that destroyed 7 homes and Bengal St. See Figure 5 for topography at cross sections M-M' and L-L'. Note: The bridge in the 1969 photograph was built after the flood.

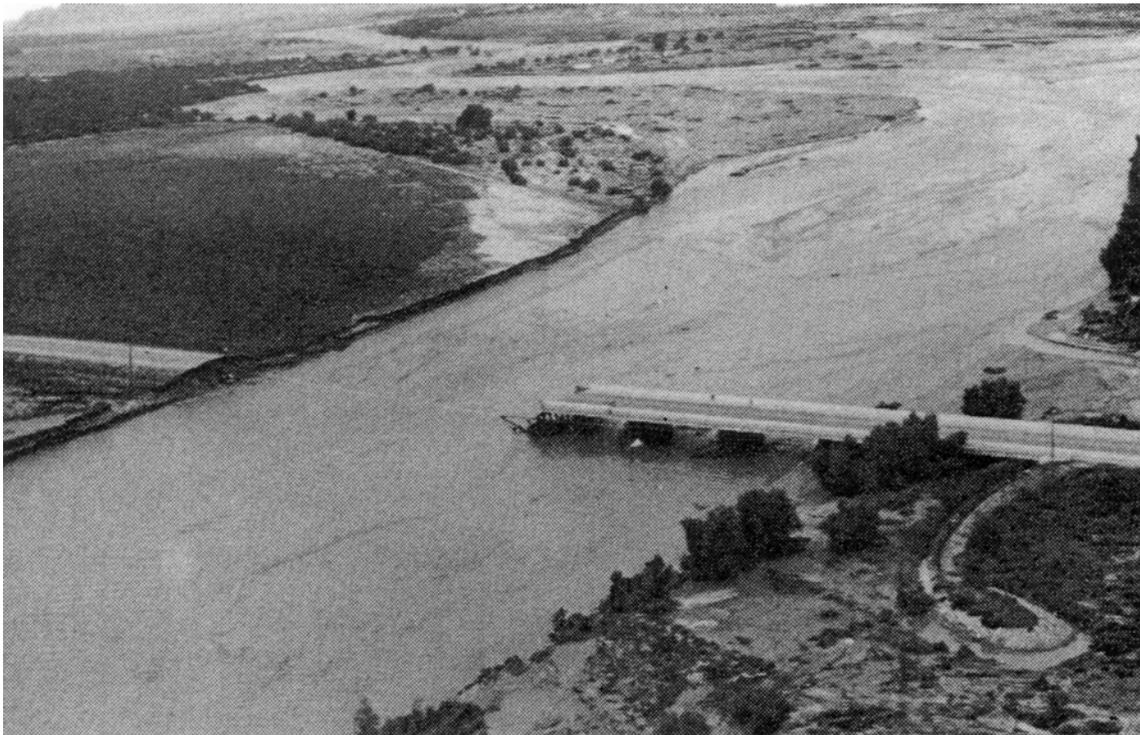
*Figure 2. Aerial photograph of the Ina Road Bridge, Santa Cruz River, AZ, looking northwest after the 1983 flood (PCDOT, 1984). The gap in the roadway was due to failure of the west abutment by lateral erosion.*

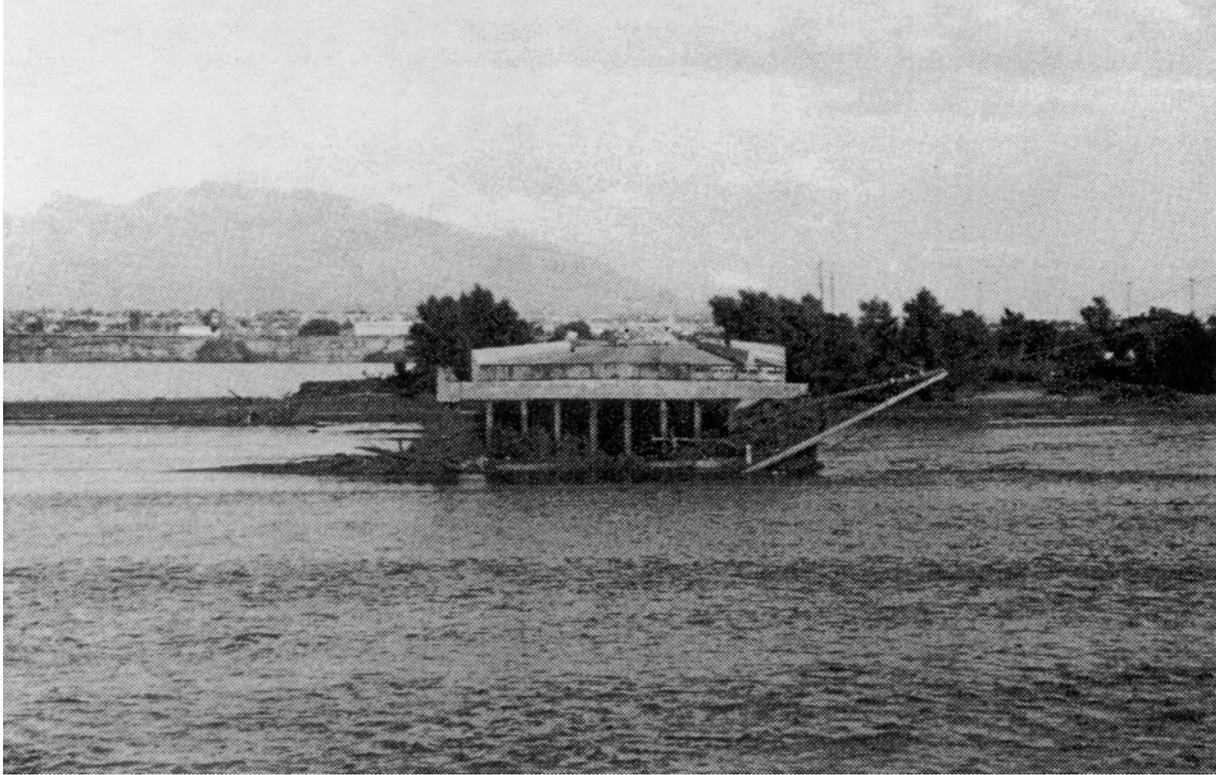
*Figure 4. Photograph of the Ina Road Bridge, Santa Cruz River, AZ, looking east from the west bank of the river (PCDOT, 1984). Note the breached and flooded Site #5 pit in the upper left of the photograph.*

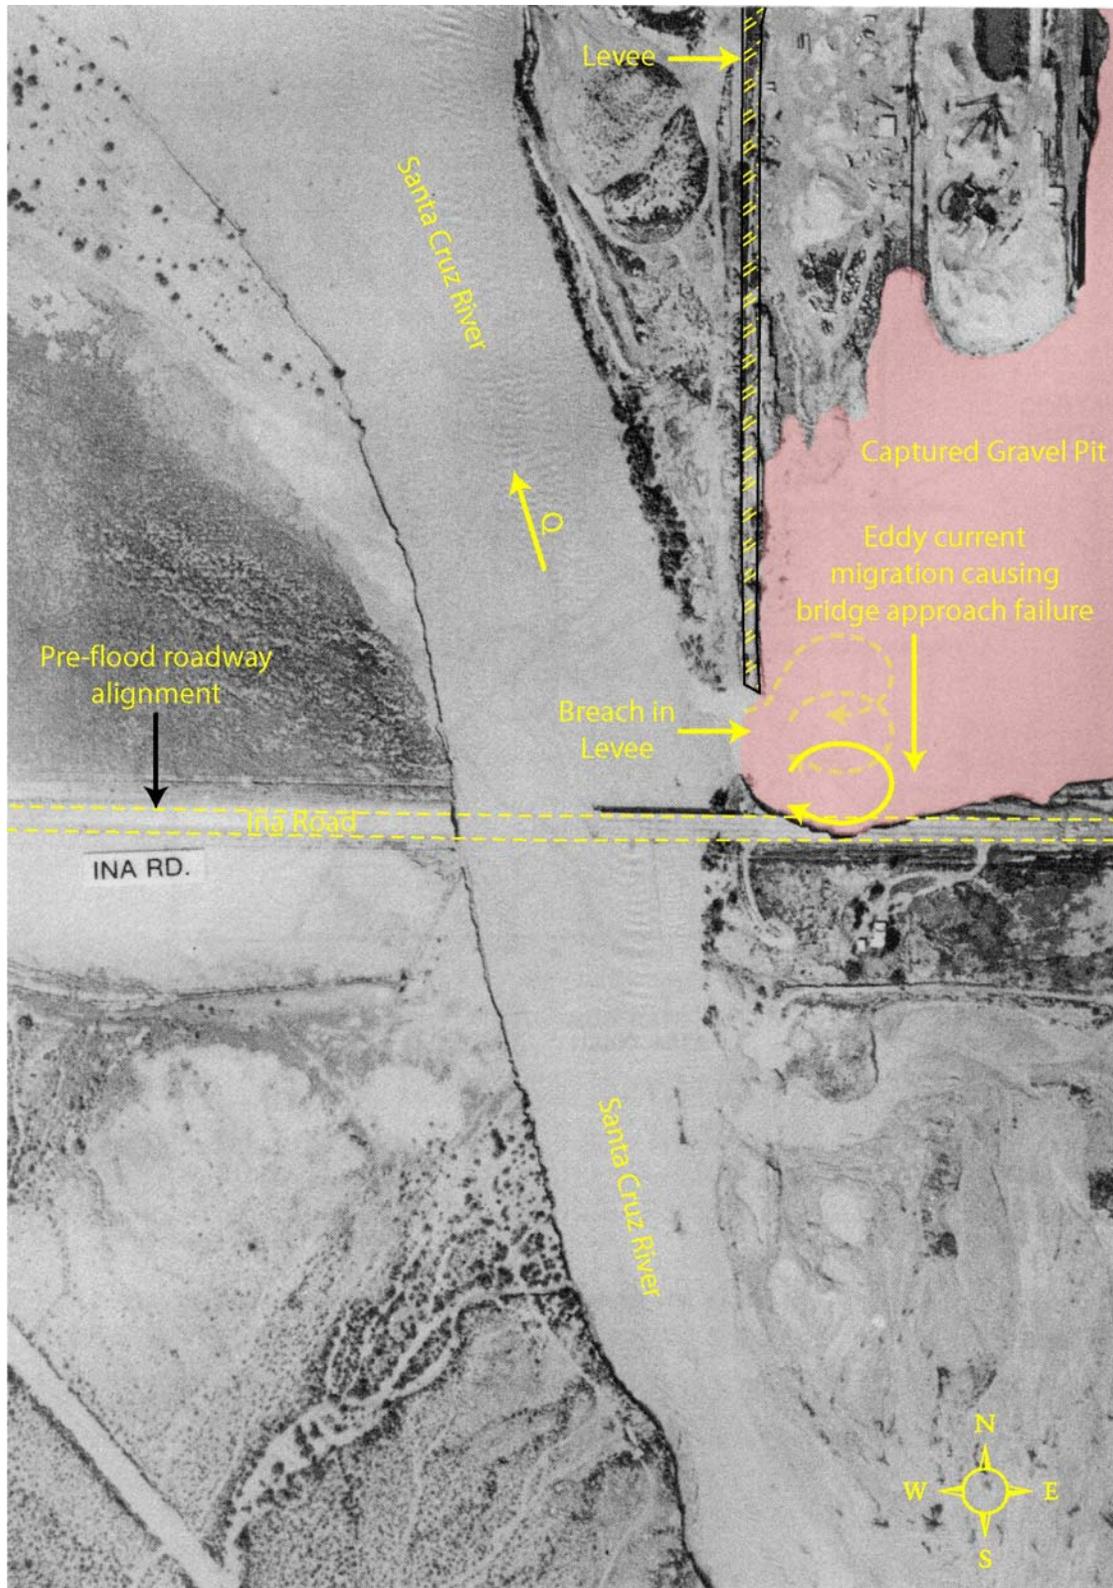
Figure 6. Ina Rd Bridge during the October, 1983 flood. Note the erosion of Ina Road east of the bridge and main channel due to circulatory currents and local inflow to the pit (PCDOT, 1984).

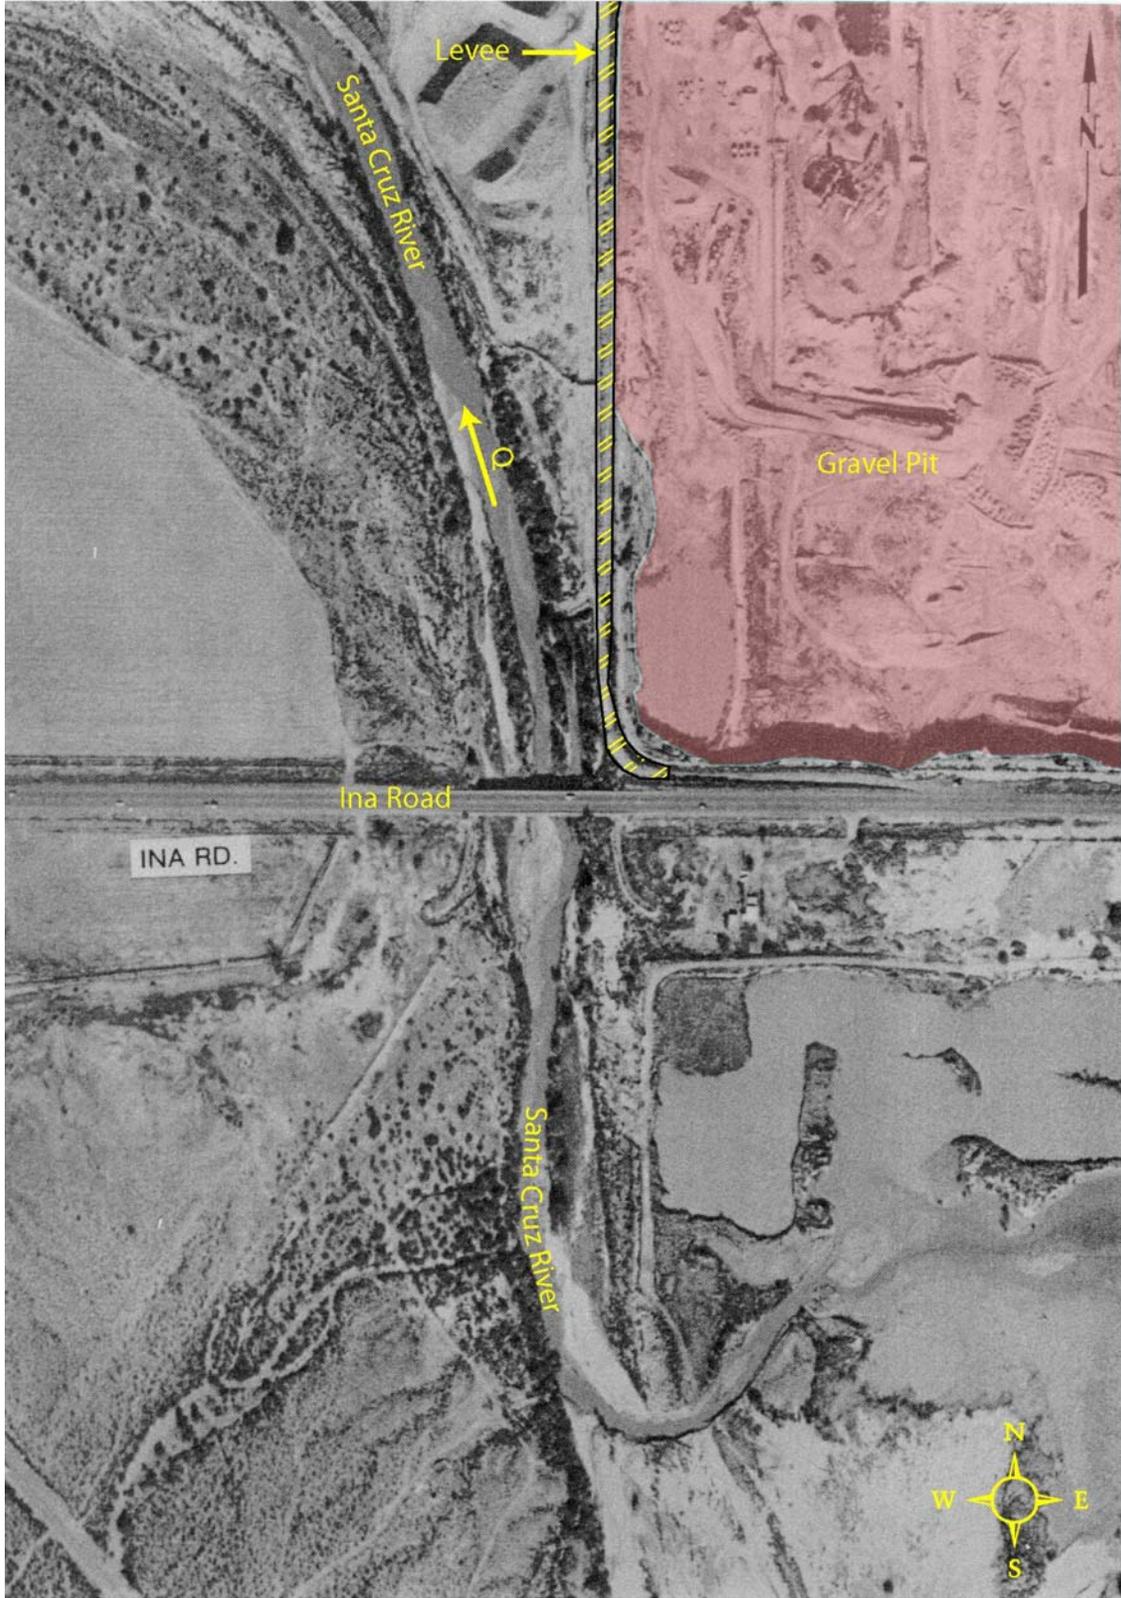
Figure 7. Ina Road Bridge site in December, 1982 (from PCDOT, 1984). Note the steep side walls and narrow setback from Ina Road at the Site #5 Pit, as well as headcut into the inundated pit south of Ina Road.

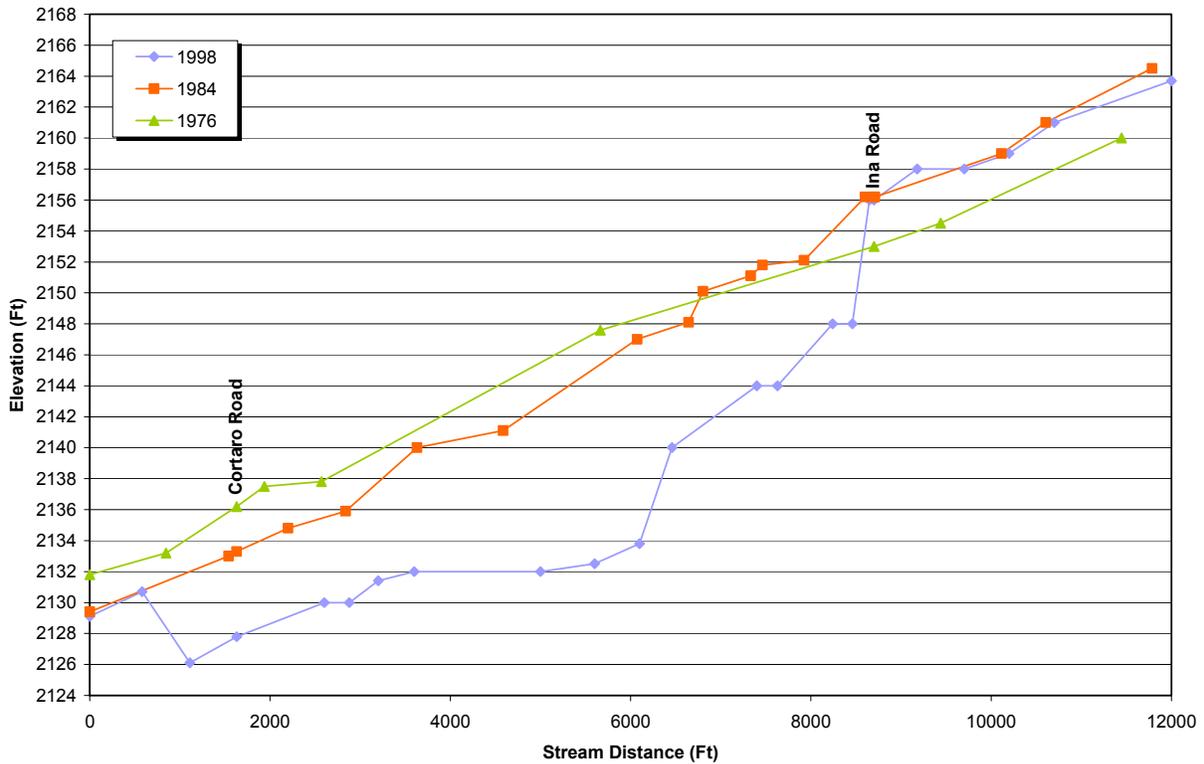
Figure9. Changes in channel minimum bed elevations in the Santa Cruz River from 1976 to 1998.

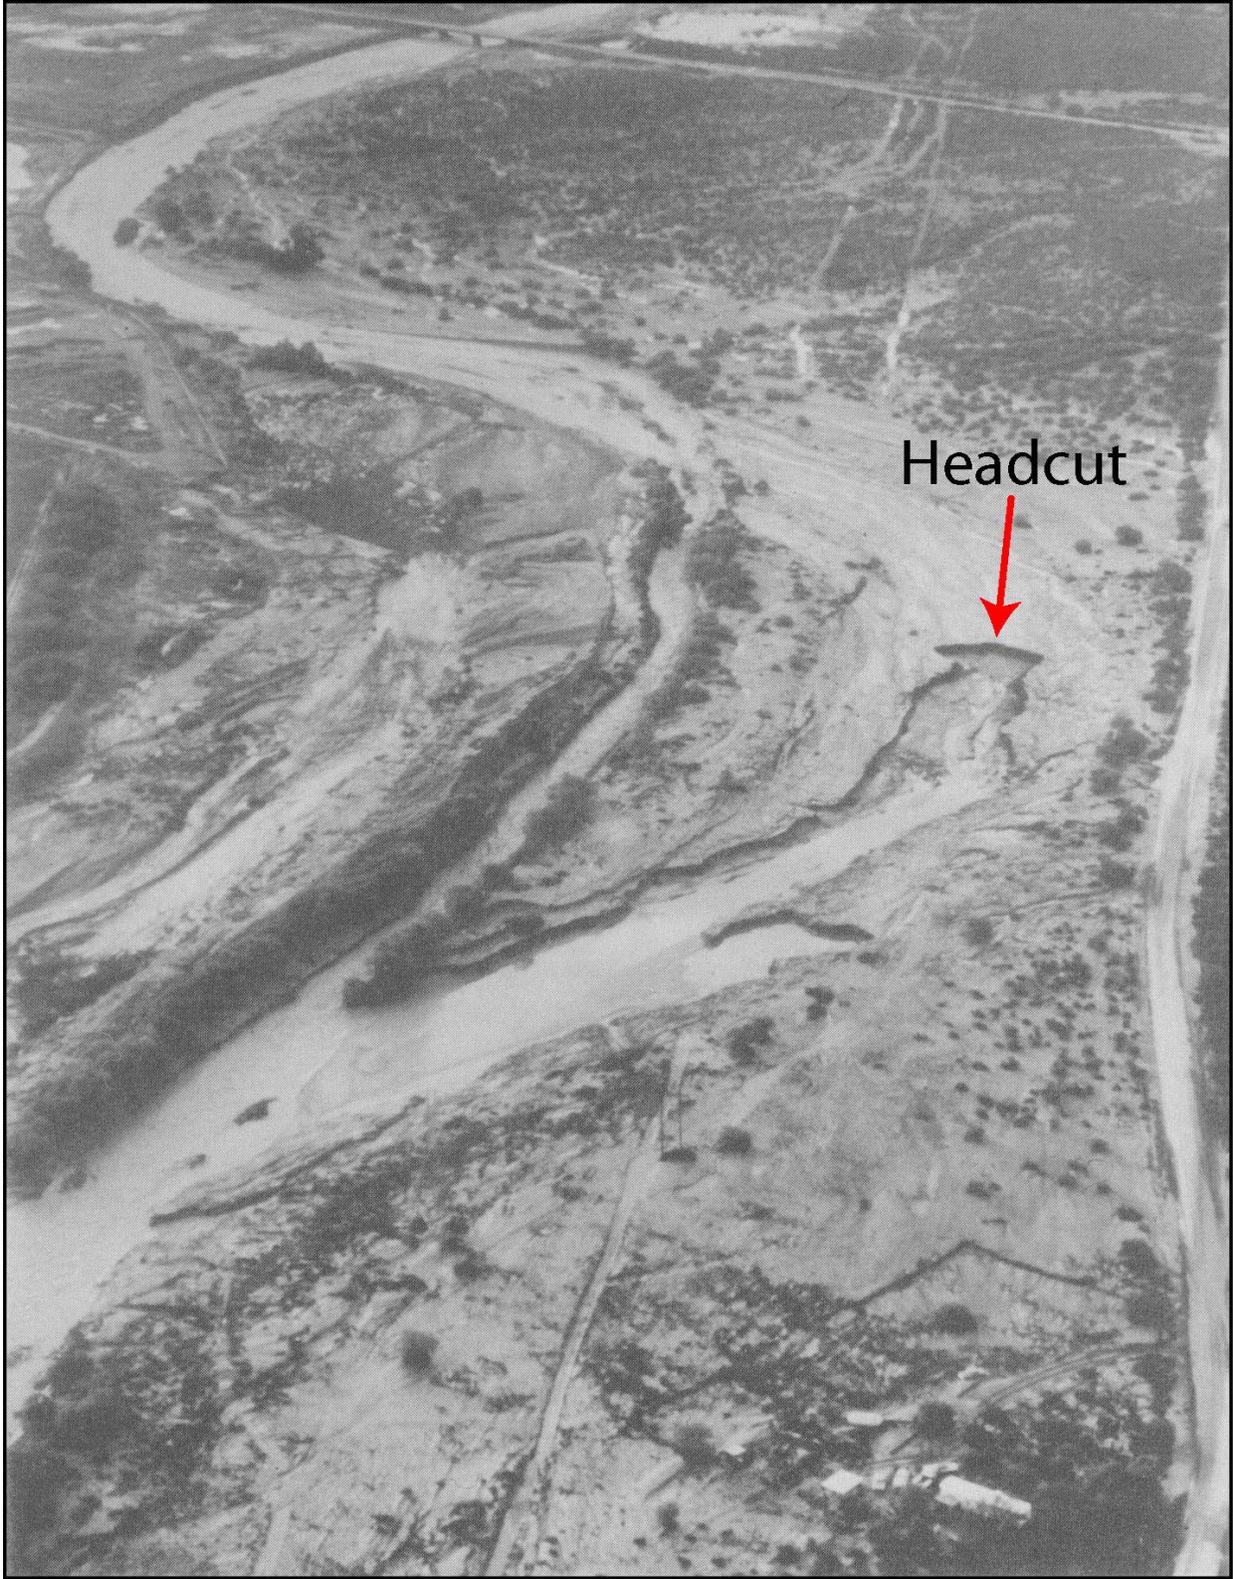
Figure 10. Headcut on the Santa Cruz River floodplain, October 1983 (Baker et al., 1988).

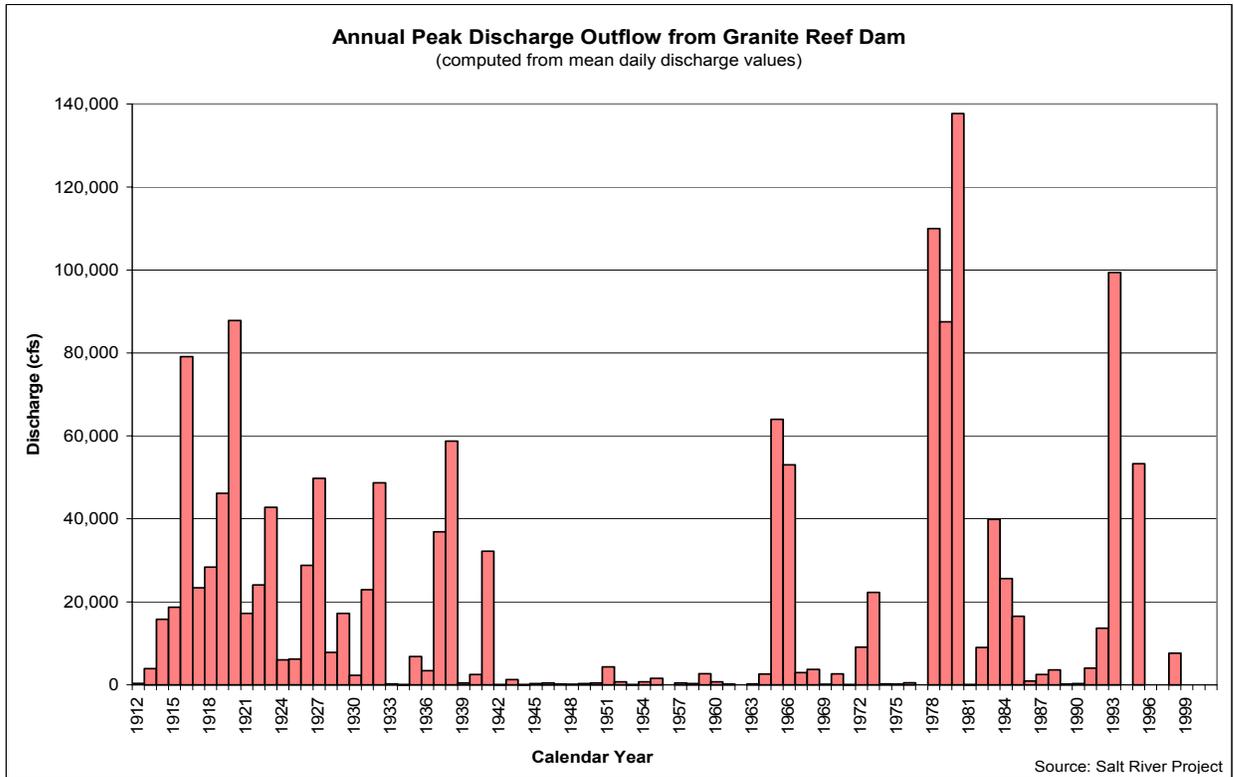
Figure 3. Estimated Salt River annual peak discharge downstream of Granite Reef Dam.

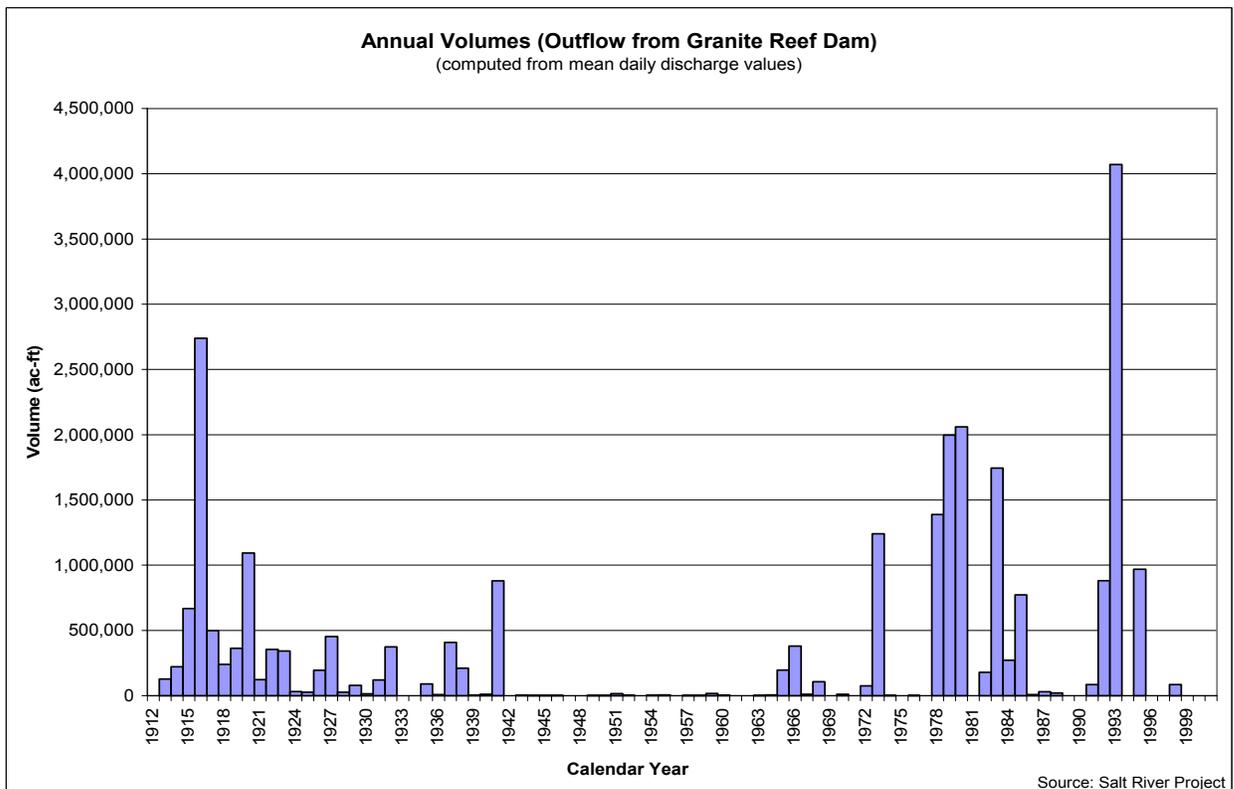
Figure 4. Estimated Salt River annual flow volumes downstream of Granite Reef Dam.

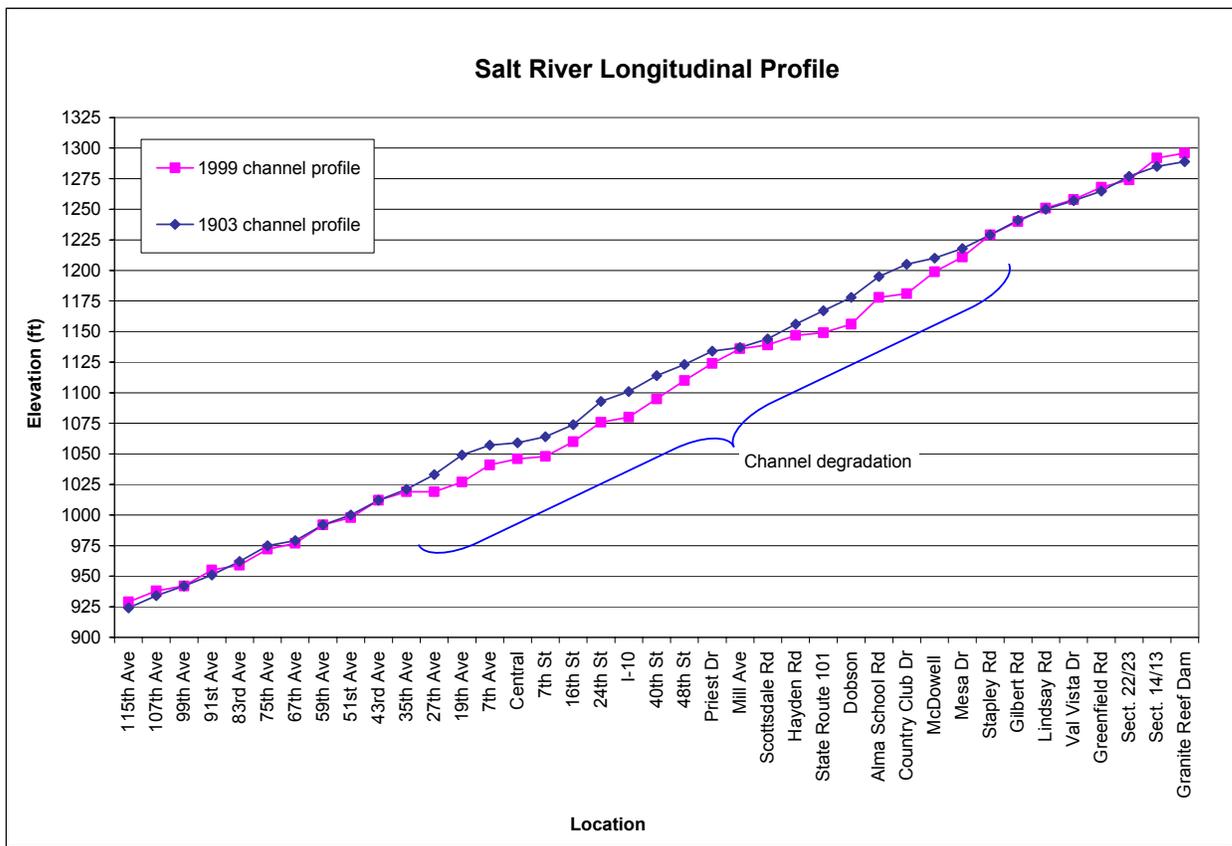
Figure 5. Longitudinal profiles of the Salt River in 1903 and 1999.

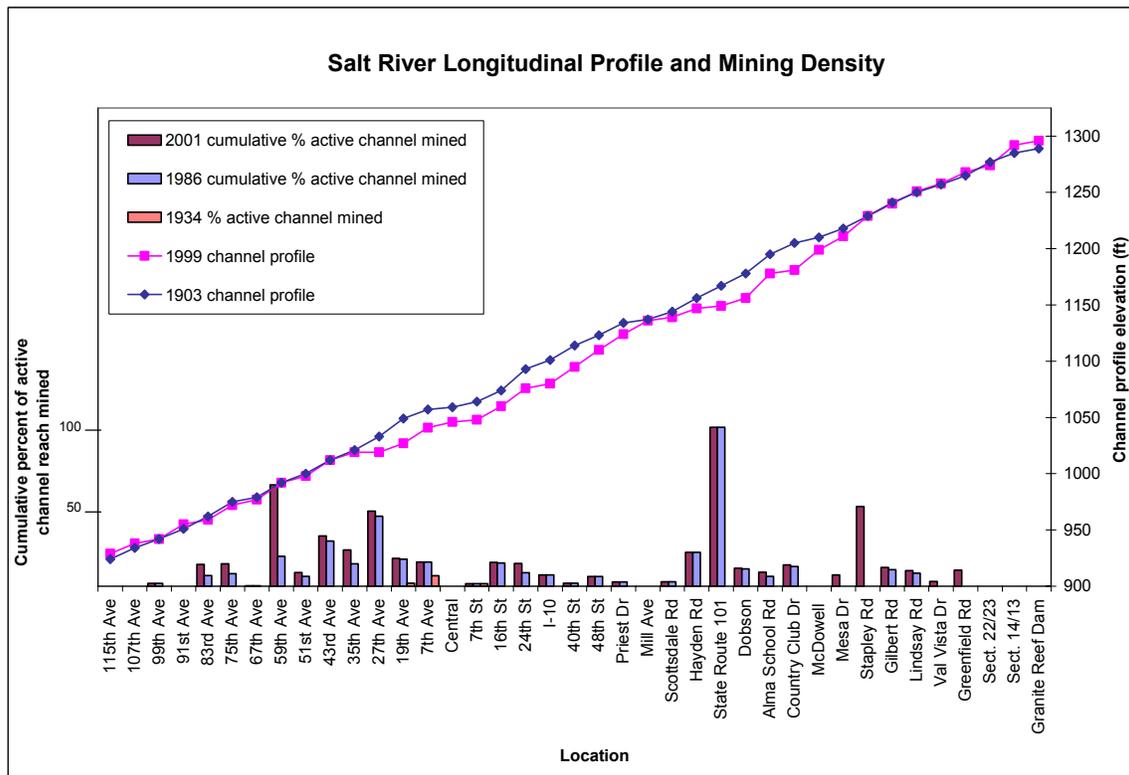
Figure 7. Mining density in 1934, 1986, and 2001 relative to long-term degradation.

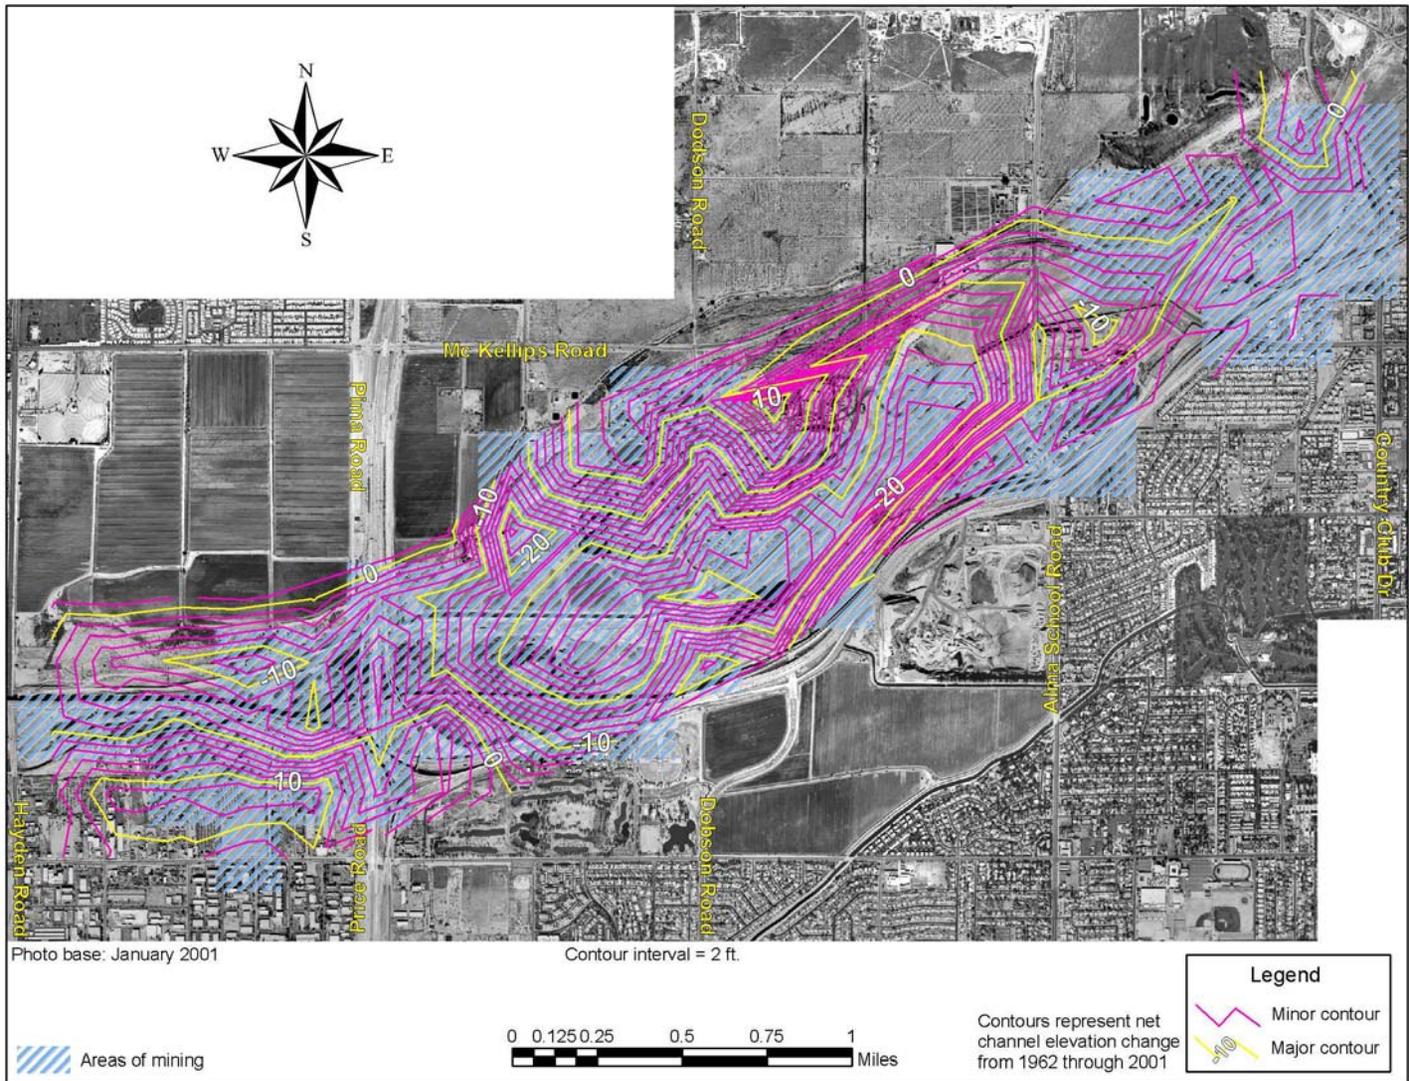
Figure 13. Topographic map of long-term channel elevation change (1962-2001) in the Hayden-Country Club Mining Cluster.

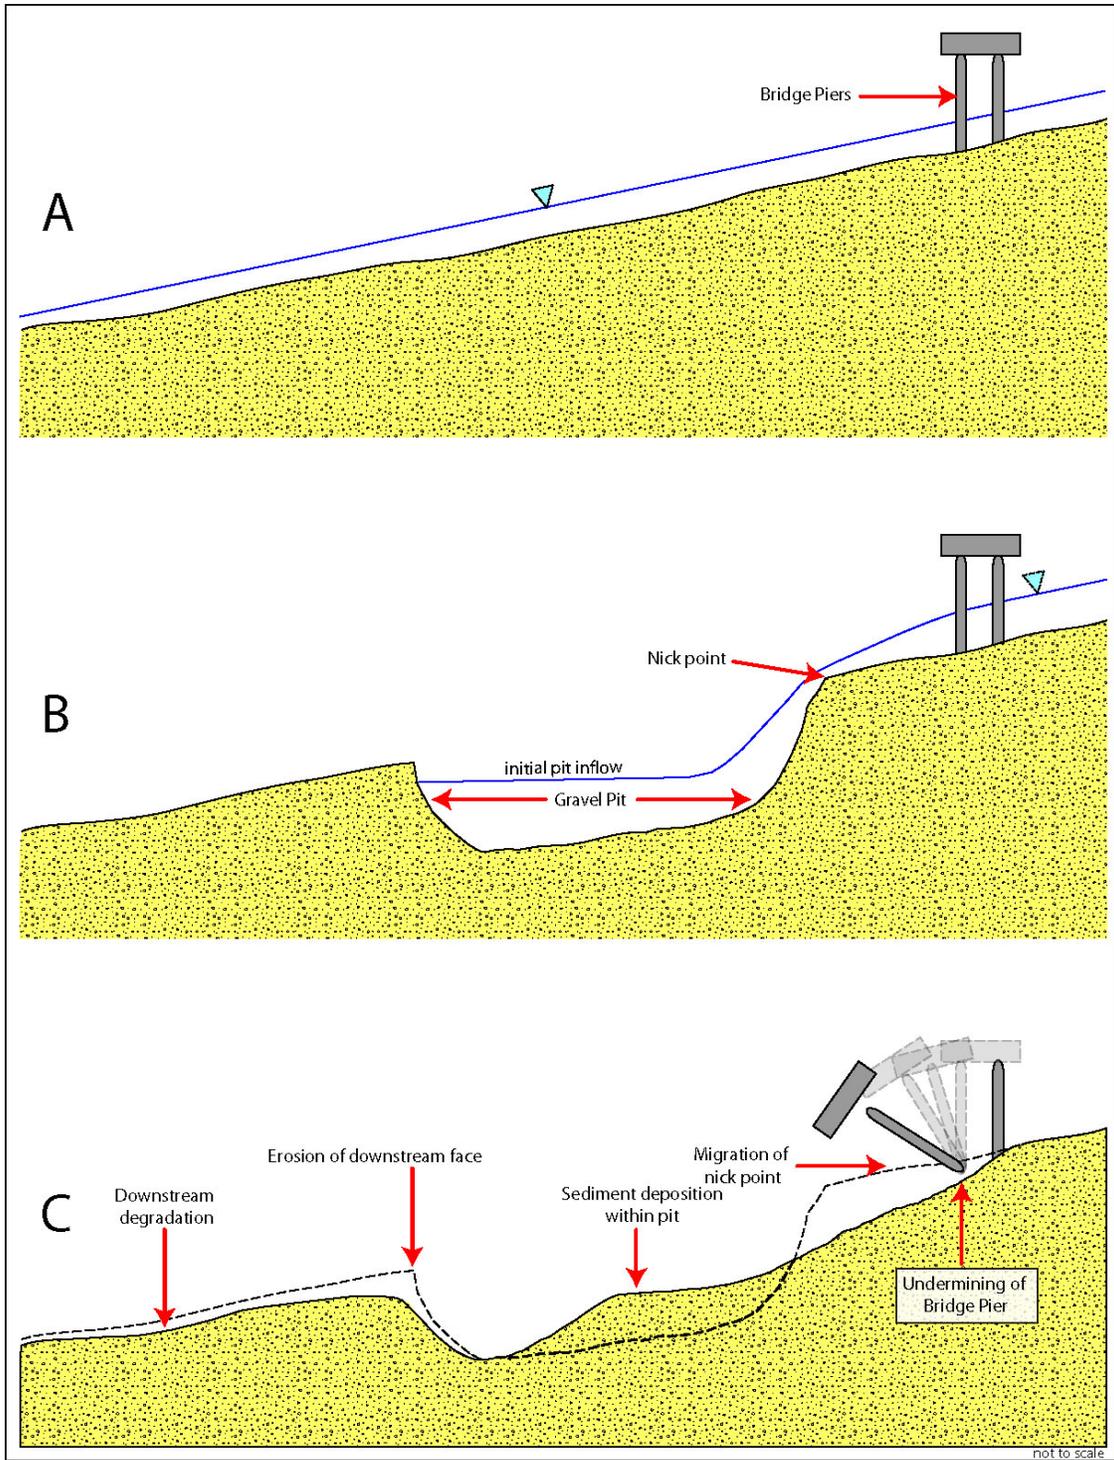
Figure 14. Schematic illustration of potential erosion due to in-stream mining. (A) Energy in is equilibrium, no net deposition or erosion occurs. (B) During flood, flow into the excavation creates a nick point and headward erosion begins. (C) Continued nick point migration upstream can undermine bridge piers, causing collapse. Also, note the erosion at the downstream edge of the excavation and deposition in the excavation due to sediment trapping.

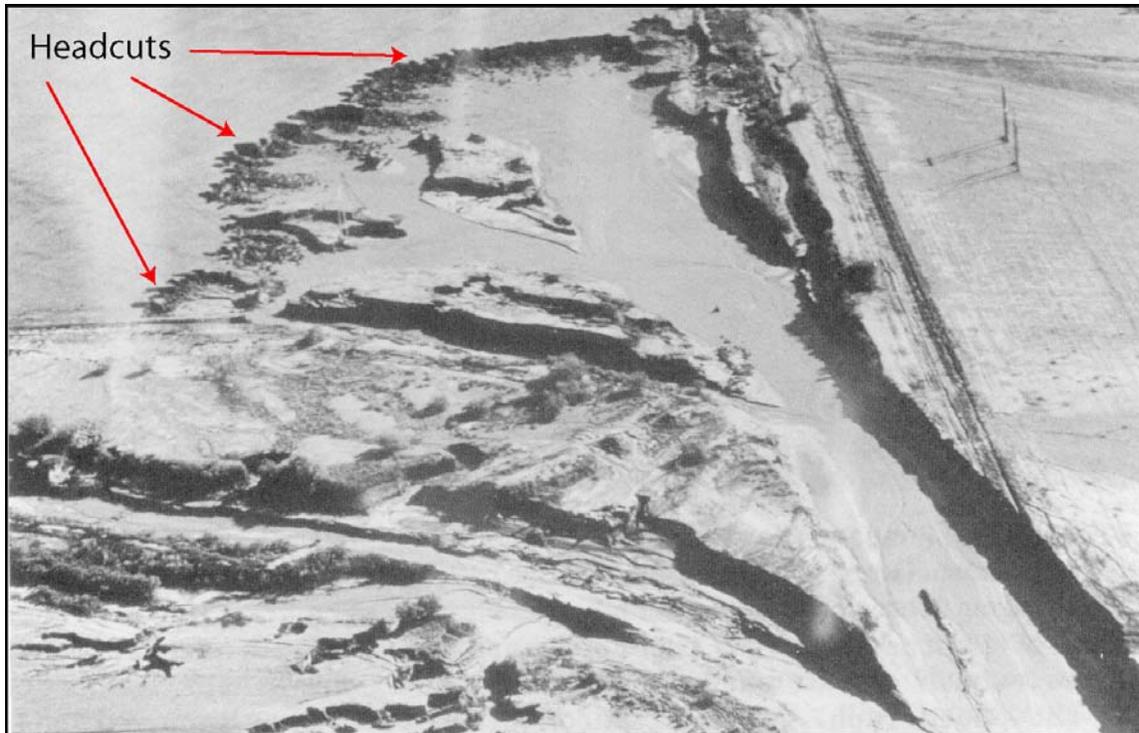
Figure 15. Headcutting on the Santa Cruz River 9 miles northwest of Marana, AZ, October 1983 (Saarinen et al., 1984).

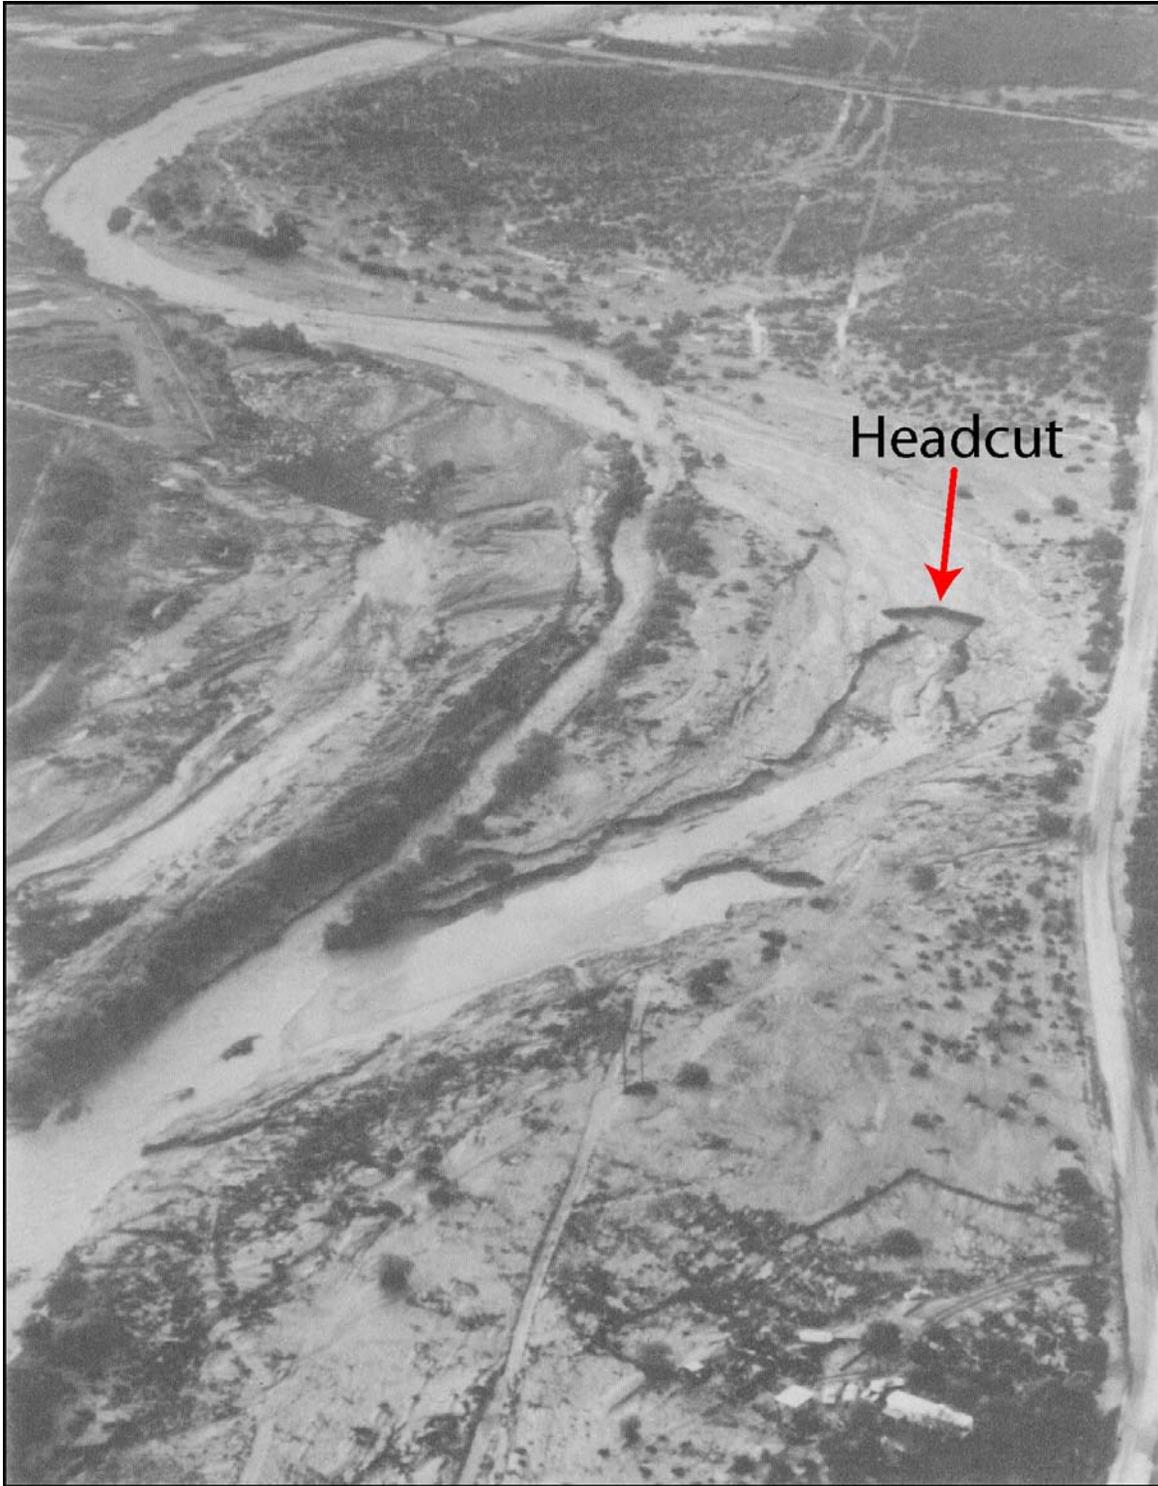
*Figure 17. Headcuts on the Santa Cruz River floodplain, October 1983 (Baker et al., 1988).*
