Draft Final Report

Fort Pearce Wash Master Plan

A road map for reconstruction,
management, and long-term maintenance

Fort Pearce Wash

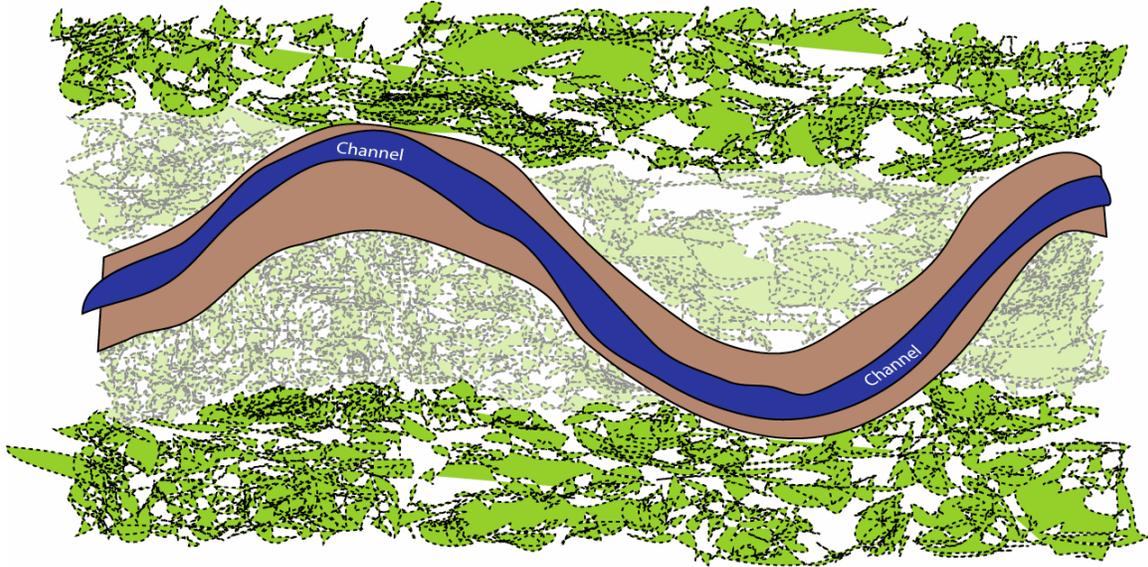
Figure 20 Exotic species removal: Stage I.

Initial removal of salt cedar should be in areas adjacent to the active channel. Point bars on the inside of meander bends are prime candidates. These areas have higher soil moisture levels and a disturbance regime that will benefit the native species.

removed. Do not remove large thickets of established vegetation (native or non-native) in the low or high terrace areas without replacing them with structure of similar roughness. (Figures 20, 21, 22, 23).

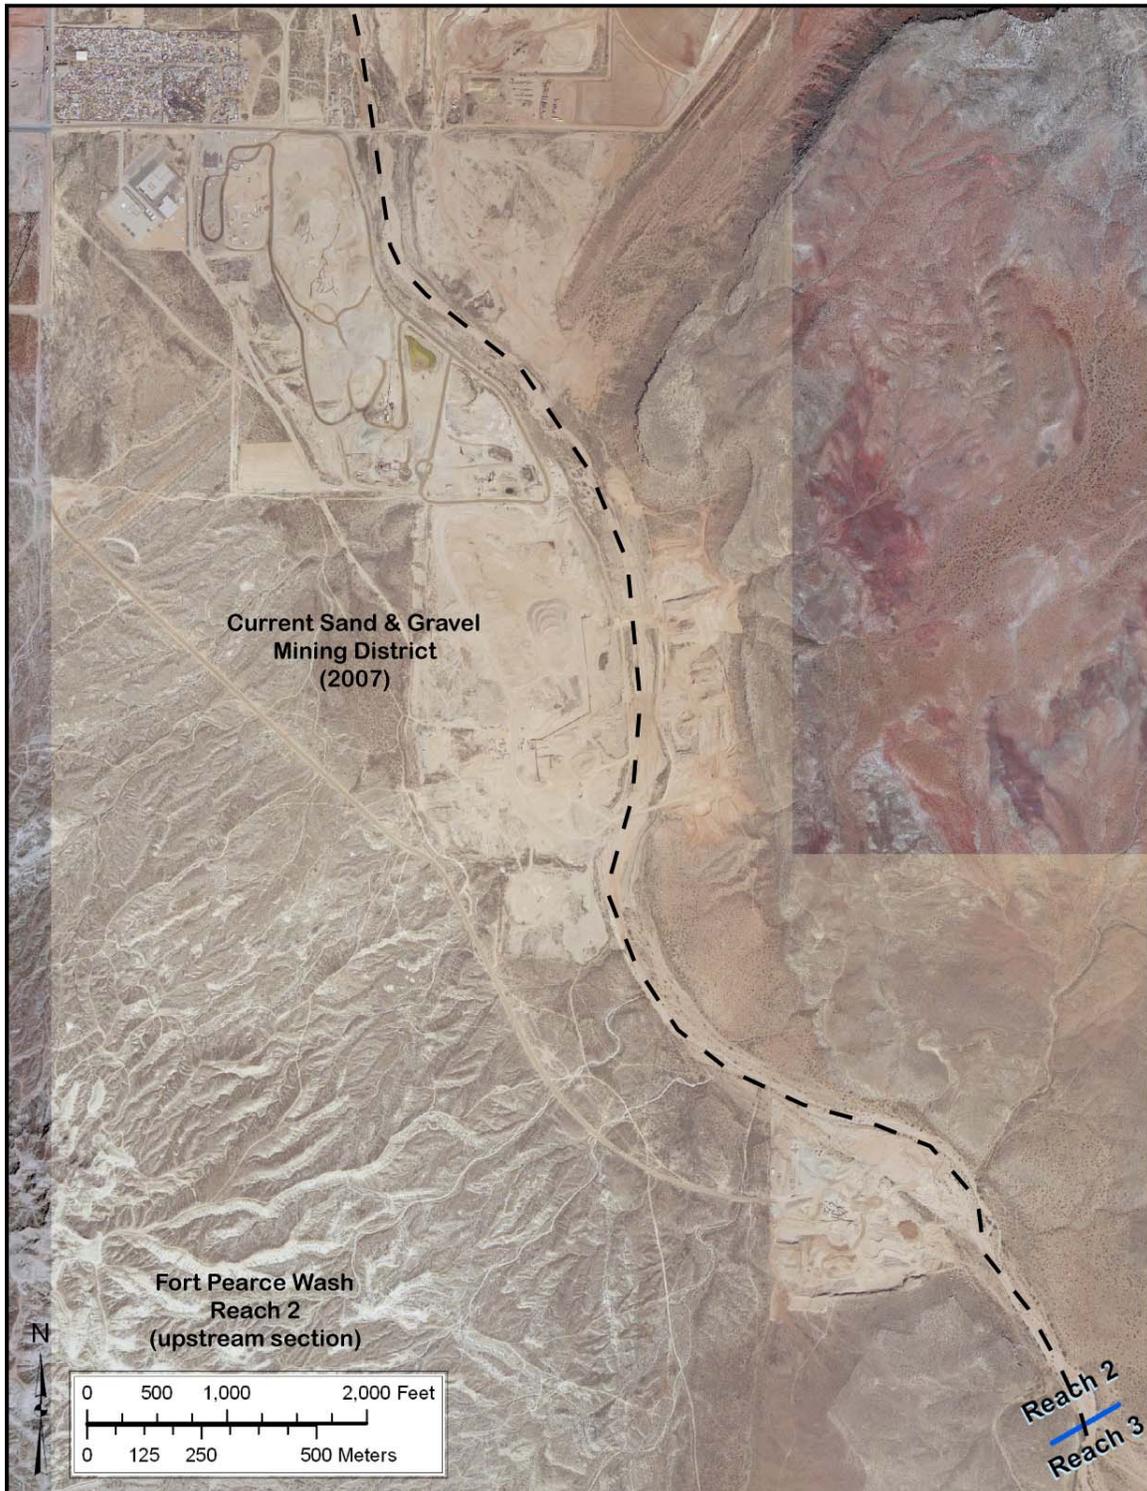
Figure 29 Reach 2 map (upstream section)

This reach is currently dominated by active sand and gravel mining operations (Figures 29 & 30). As the properties surrounding Fort Pearce Wash are developed, reclamation efforts should be consistent with recommendations presented in the Fort Pearce Wash Master Plan, Stream Stability Study, and Mining Plan.

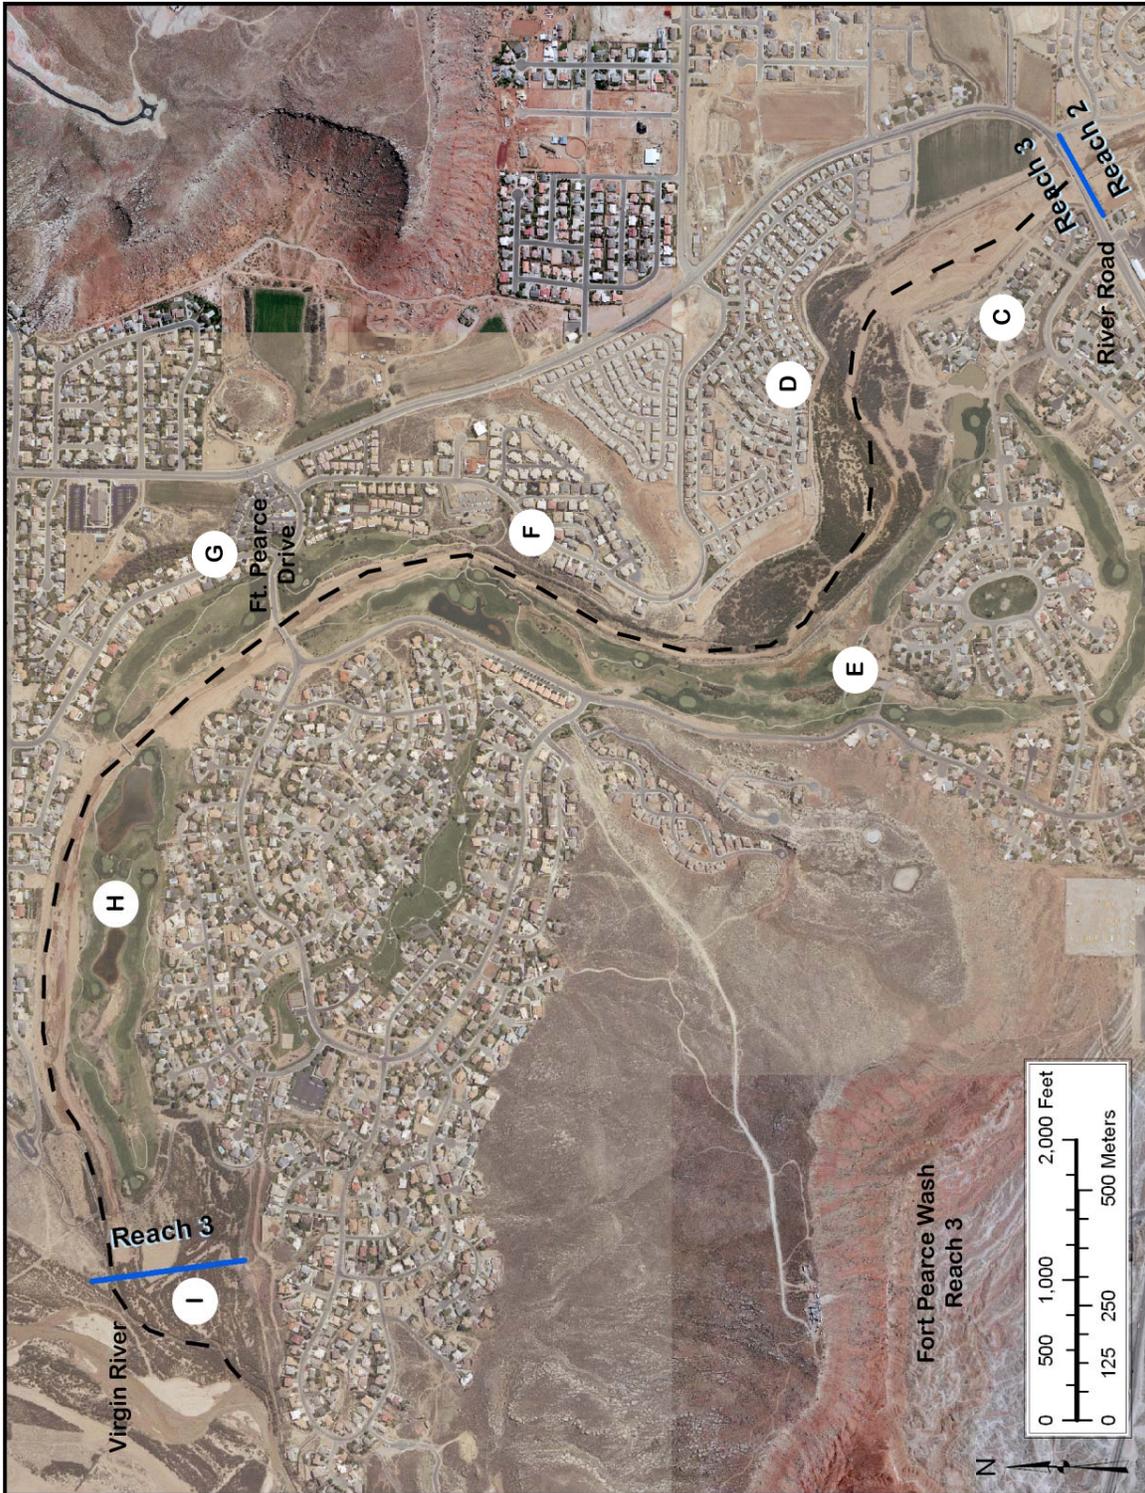
Figure 31 Reach 3 map

Fort Pearce Wash is most constrained in this reach (Figure 31). Properties adjacent to the stream channel are largely developed. The use of golf courses adjacent to the active stream channel is appropriate and it is assumed that the golf course areas lie within the 100-year floodplain providing an outlet for overbank flows.

However, the topography of the golf courses still provide the potential for damage from flooding. Along most of the reach, berms have been installed to separate public areas from Fort Pearce Wash. Golf course areas are generally lower in elevation behind the berms. The berms will protect the areas from some flood events but once overtopped will trap flows away from the river. Either the water will pond in low areas or find a channel to reconnect with the river. Large volumes of sediment will be deposited in the ponded

areas as occurred at Sun River during the 2005 Virgin River flood. The relatively smooth golf courses will allow high velocities behind the berms and result in local scour and erosion damage. In order to minimize the potential for flood damage, it is recommended that the areas adjacent to Fort Pearce Wash be recontoured with slopes and vegetation consistent with the Guiding Principles described in this document.
